Spartan RV Chassis

Technical Service Bulletin
CSB21-250-001

- DATE:** March 8, 2021
- APPLIES TO:** This service bulletin applies to certain 2020 thru 2022 model year K2, K3 and K4 model Spartan RV motor home chassis with Vehicle Date of Manufacture (VDM) between December 12, 2019 and December 05, 2020 that are equipped with an Independent Front Suspension supplied by Reyco Granning, LLC.
- CONDITION:** The IFS lower shock mounting bracket fasteners may become loose over time and can shear, leaving the shock bracket dislodged from its intended location.
- CORRECTION:** See details below.
- LABOR ALLOCATION:** Up to 1 hour
- CLASSIFICATION:** V3
- TOOLS NEEDED:** 9/16" socket
Torque wrench capable of 35 LB-FT

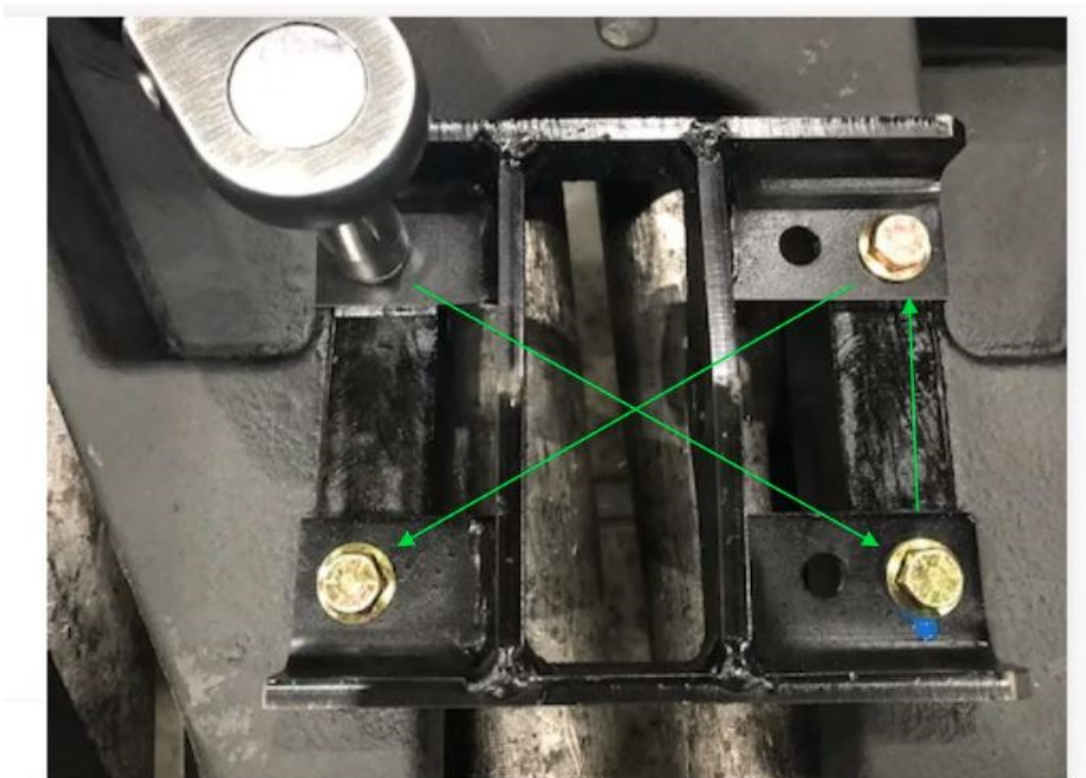
Figure 1

Referring to Figure 1, perform the following instructions one fastener at a time for each of the 4 bolts attaching the lower shock bracket to lower control arm. Use a cross pattern sequence.

1. Remove and discard bolt.
2. Clean threads in the lower control arm.
3. Install new 3/8-16 x 1.25" bolt and 3/8" Nord-Lock® washer. Torque to 35 LB-FT +/- 5 LB-FT. Mark fastener to indicate it has been torqued.

4. Repeat steps 1 thru 3 for three remaining bolts.
5. Repeat steps 1 thru 4 for opposite lower shock mounting bracket fasteners.
6. Document IFS serial number.
 - Serial number is listed on data tag located on front face of driver side air spring tower. Reference Figure 2 & Figure 3 for serial number location.
