Warranty Information

2000.2

Timing Chain Cover Repairs

Model Line: Cayenne - V6T & V8 engine
Panamera - V6T & V8 engine
Macan - V6T engine

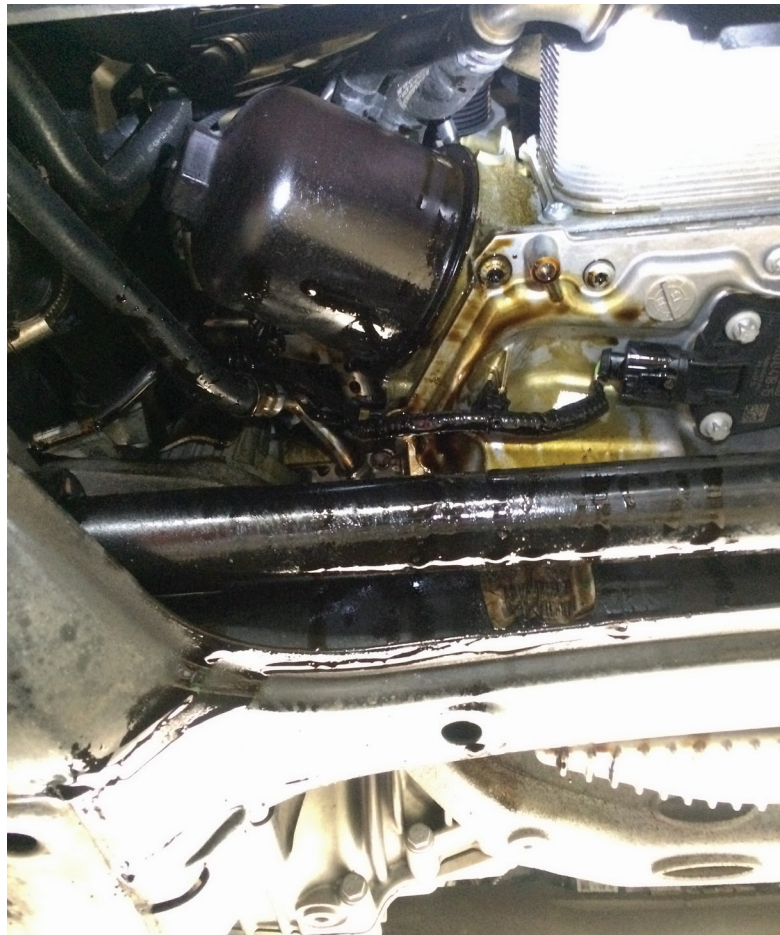
Active leak #1 Overview of the engine showing an active oil leak with oil droplets forming.

Information: If an oil leak is identified from the timing chain cover and it has been found that any part on the timing cover has failed, then the engine must be removed and the entire timing chain cover resealed per Workshop literature WM 153319.

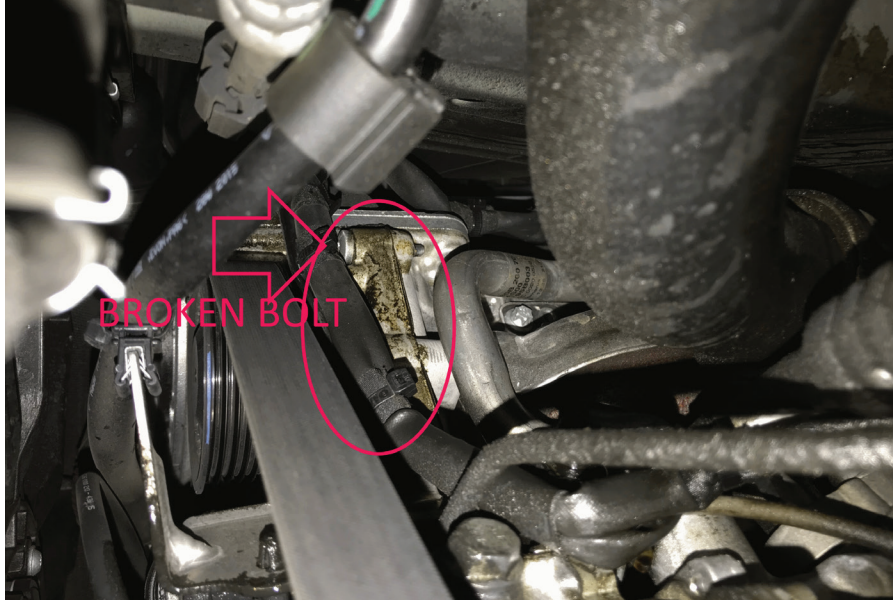
A picture showing the location and source of the oil leak.

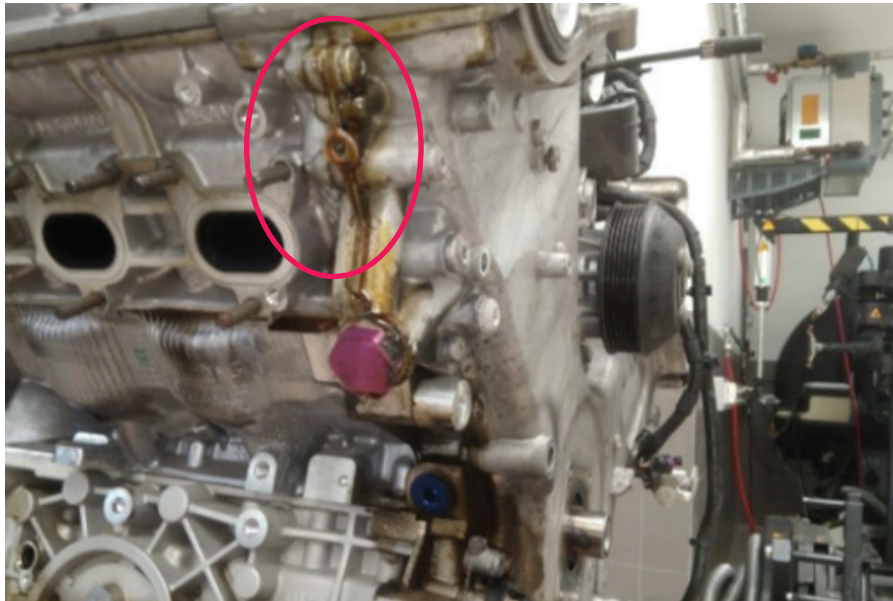
A picture of the location and source of oil leak with engine clearly removed
is required

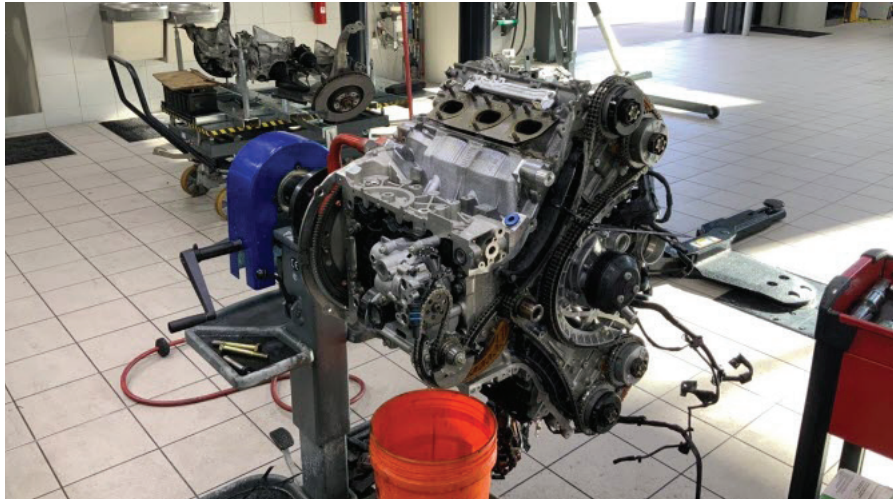
A picture showing the engine on the stand with all necessary parts removed per the Workshop literature WM 153319 and labor operations 15331940 (for Macans) and 15331990 (for Cayennes). Parts that should be removed include the transmission, exhaust manifold, cylinder head covers, turbochargers, oil guide housing, and the oil pan.

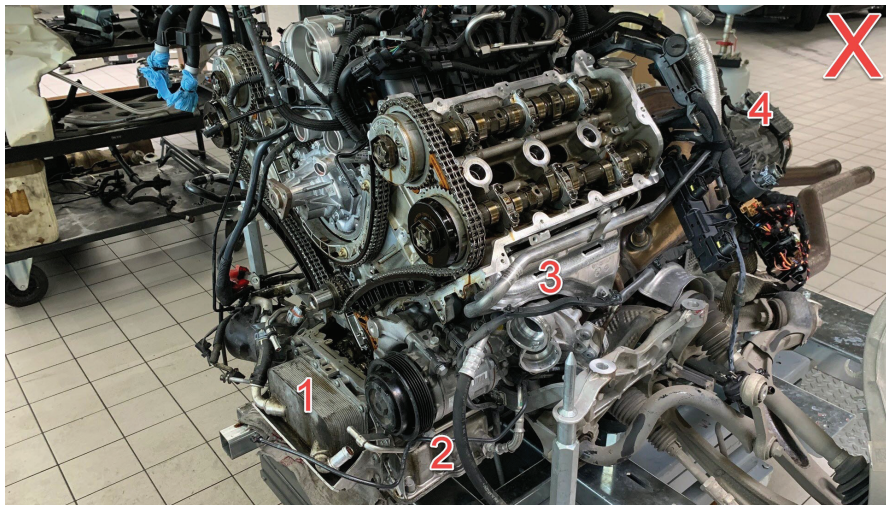
This picture is not acceptable documentation. The picture shows the repair was performed improperly because the timing chain cover was removed without performing the work per the Workshop Manual. Among other components, the oil guide housing (1), oil pan (2), turbocharger (3), and transmission (4) were not removed and the engine was not mounted to the assembly support as described in WM 153319.

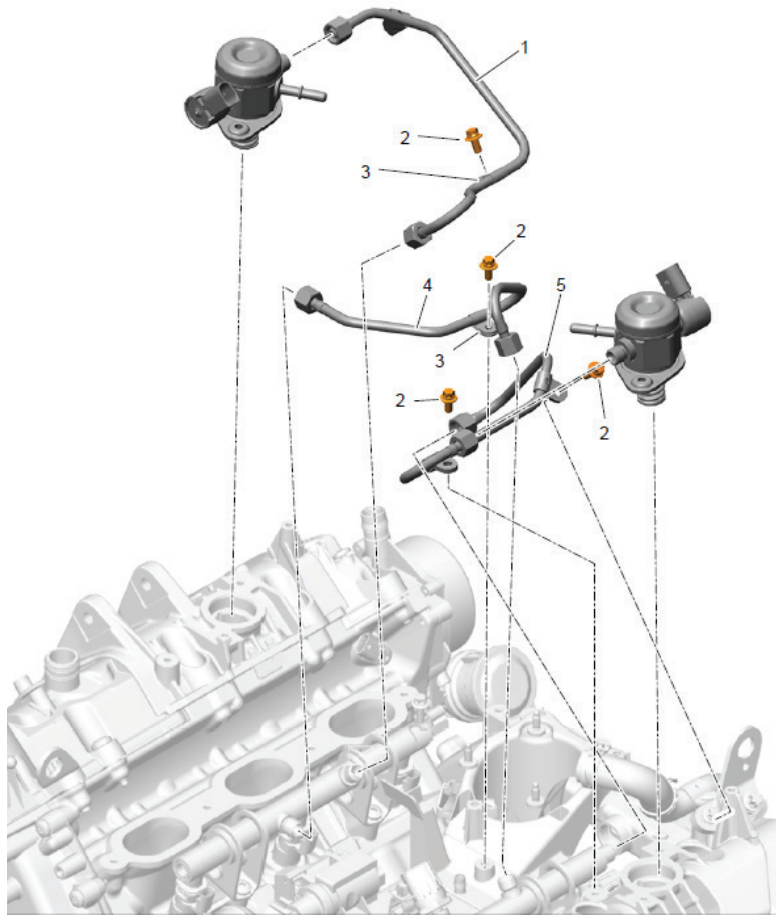
This image shows the high pressure fuel lines that have to be removed before the cylinder head covers can be removed.

Per the workshop manual for Macan S, Macan GTS, Macan Turbo, and Cayenne S, the high pressure fuel lines must only be used once and must be replaced after removing or loosening union nuts. Please ensure that new fuel lines are installed on Macan S, Macan GTS, Macan Turbo, and Cayenne S vehicles when performing the timing chain cover reseal.

For the Cayenne GTS, the workshop manual states that the fuel lines must not be bent and, if they are, then bent fuel lines must be replaced. Please ensure that the fuel lines are inspected thoroughly before they are reused and replaced if bent.
