# Service Alert

**360° VIEW MONITOR SYSTEM AIMING PROCEDURE IS  
UNSUCCESSFUL**

**Service Alert No.:** SA-022/21

**Last Issued:** 03/08/2021

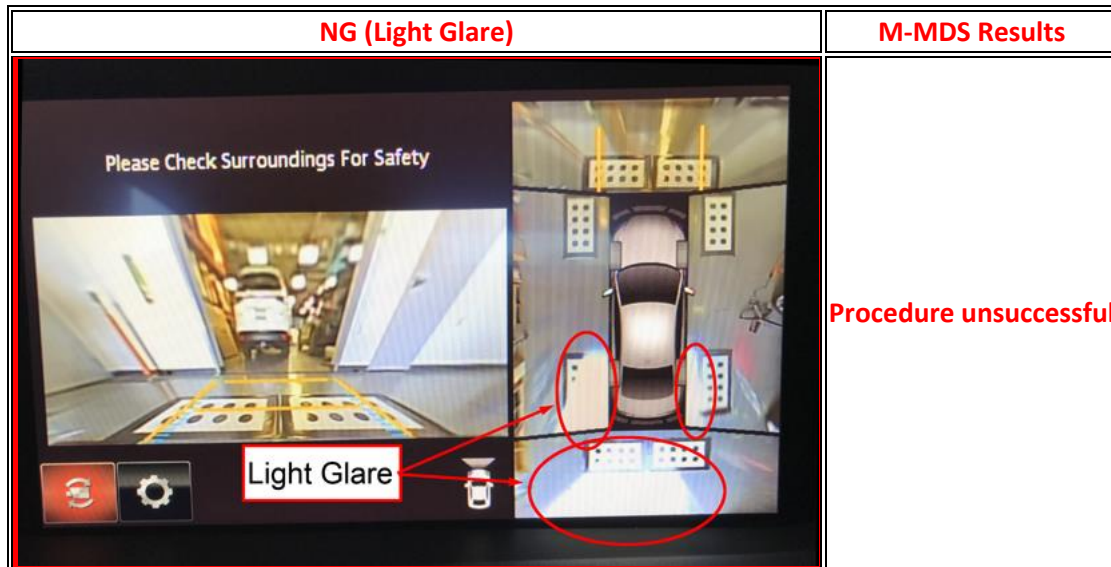
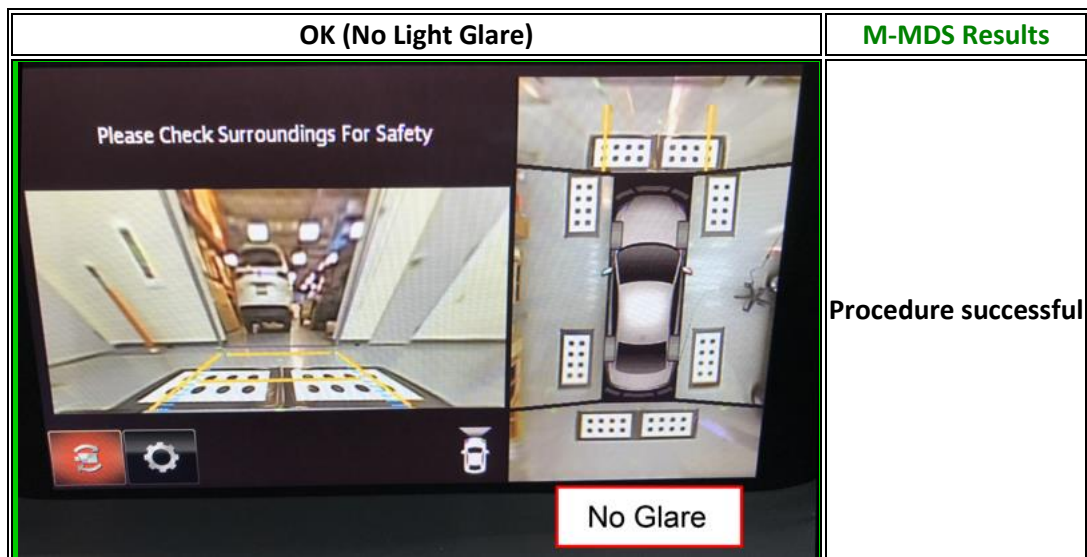
Light glare can be identified by using the center display as shown below:

If light glare is found using the center display, remove the light glare.

After light glare is removed, perform the aiming procedure again. M-MDS should now show "Procedure successful".
