## PRODUCT ADVISORY

**PA688**

**MODELS AFFECTED:** Terex Aerial Devices & Digger Derricks on Freightliner Chassis

**SUBJECT:** Freightliner Chassis with Tri-Axle Rear Air Suspension

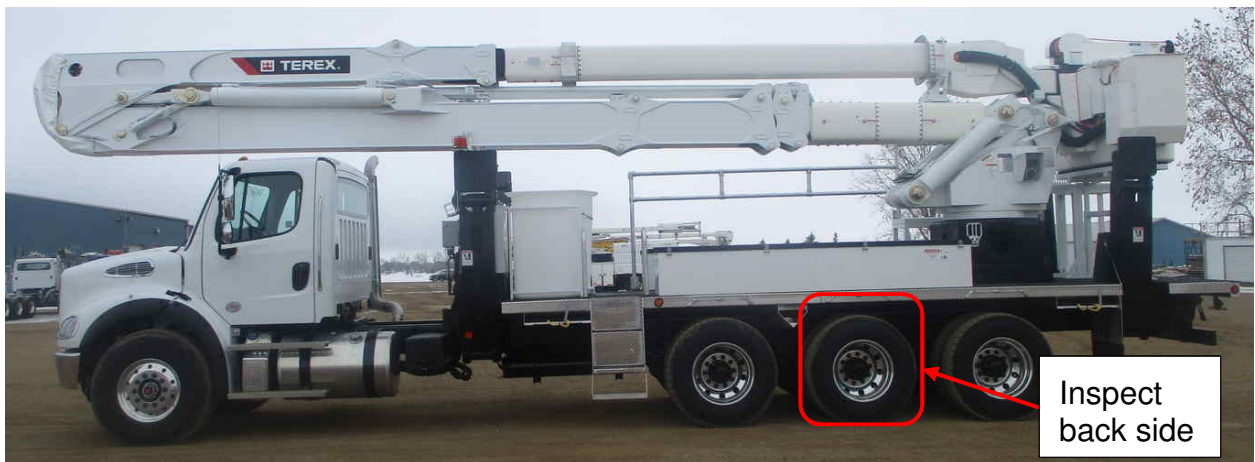
**Figure 1. Area of vehicle to inspect**

Terex aerial devices and digger derricks, produced from January 2015 to June 2020, installed on Freightliner chassis with Hendrickson Primaxx tri-axle rear air suspension may have the ride height control linkage contact the bottom of the subframe. Repeated contact of the ride height control linkage with the subframe may cause the linkage to fail. Failure of the linkage may affect the rideability of the chassis as the chassis will not be able to self-level.

Inspect the ride control linkage, including the attachment points as shown in Figures 1, 2 & 3, for signs of damage such as bending and/or cracking or indications of contact with the bottom of the subframe. Complete this inspection at the next scheduled inspection interval or at the next scheduled servicing of the chassis. If the linkage has failed, limit road travel to reduce the amount of shock loading into the aerial device or digger derrick until repaired.

If the ride control linkage contacts the bottom of the subframe or shows any damage, contact your nearest Freightliner dealership to determine the required repairs and reference Freightliner Customer Advisory Letter CAL FTL 32-006. If you are unable to locate your dealership, go to the Freightliner website, [freightliner.com](http://freightliner.com), and click the DEALERS button in the upper right-hand corner to search for the local dealership.

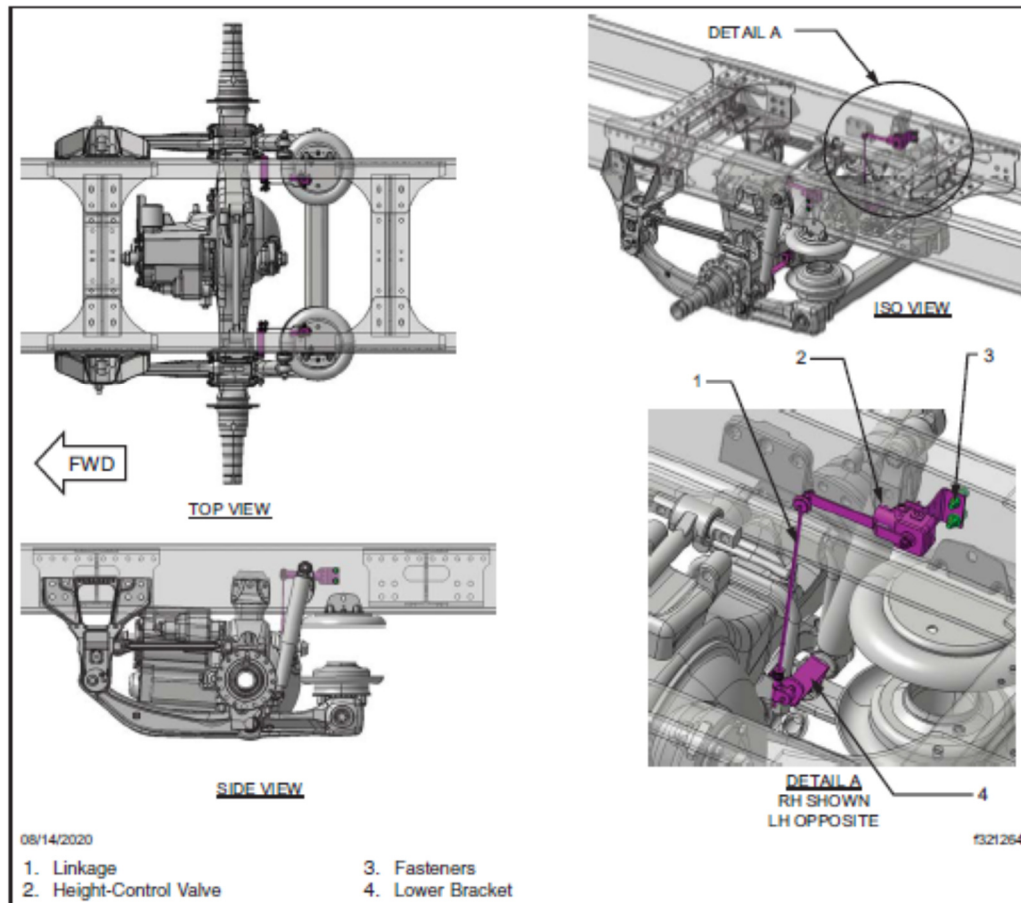
**Fig. 1, Location of Height-Control Valves**

The attached document provides work instructions for relocating the height-control valve downward 1.62 inches (41.3 mm) to prevent the linkage from protruding above the top flange of the frame when the suspension air is dumped.

1. Park the vehicle on a level surface, set the parking brakes, and *chock the tires*.
2. Put the transmission in neutral and build the air pressure to at least 100 psi. Shut down the engine.
3. Release the parking brakes.
4. Locate the height-control valves installed just rear of the mid-axle inside the left-hand and right-hand frame. See [Fig. 1](#).
