HYUNDAI Technical Service Bulletin	GROUP Body Electrical	NUMBER 21-BE-004H
	DATE March, 2021	MODEL(S) Various
SUBJECT: WIRELESS CARPLAY DISCONNECTION

This TSB supersedes TSB# 20-BE-014H to include a note referencing to another TSB.

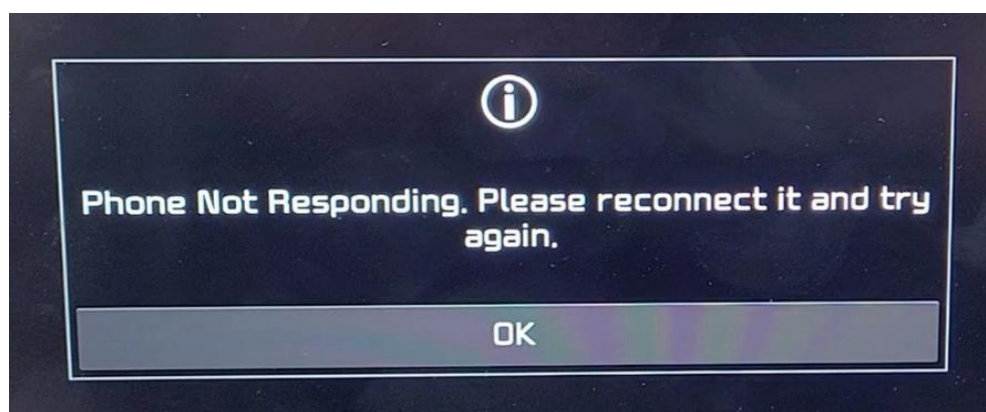
Description: When using Wireless CarPlay, the system may intermittently auto disconnect. When Wireless CarPlay is disconnected, a pop up message "Phone Not Responding. Please reconnect it and try again" will appear on the radio screen.

NOTE 1: If the intermittent Wireless CarPlay disconnection occurred, do not replace the radio. The disconnection phenomenon is caused by the Apple IOS software. Apple IOS software intermittently pause the data transmission, causing the communication interruption between the radio and CarPlay.

NOTE 2: A software update is available for certain models, refer to TSB 21-BE-002H for more information. The software update helps reduce the disconnection occurrences, until Apple provides a software update to correct the condition.
