Technical Service Bulletin

GROUP CAMPAIGN	NUMBER 21-01-014HG
DATE MARCH, 2021	MODEL(S) G80 (DH)

SUBJECT: TCU UPDATE – DH TCU LOGIC (SERVICE CAMPAIGN T16G)

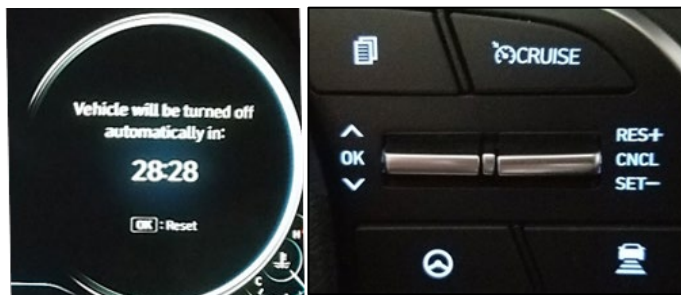
The TCU Update takes approximately 15 minutes to perform. However, the vehicle is equipped with a 30 minute factory default Vehicle Auto-Shut Off feature.

If the **Vehicle Shut-Off Timer: XX:XX** appears on the cluster, press **OK** on the steering wheel to reset the timer before starting the ECM update.

In the event of ECM update failure due to Vehicle Auto-Shut Off activation, perform the TCU update again in the **Manual** mode.
