TECHNICAL TOPICS

Tapping Noise from A-Pillar Area

20 – 21MY Defender

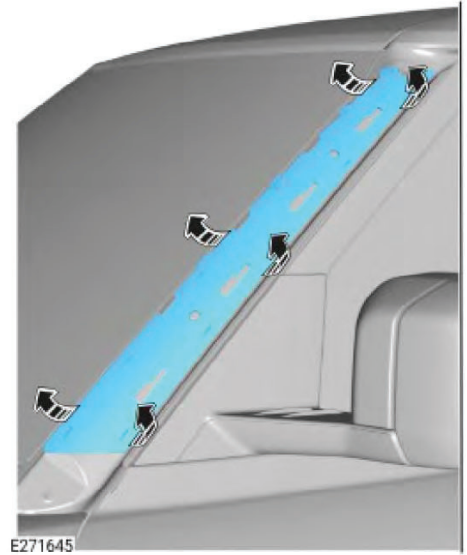
- A customer may report a tapping type noise while driving from the windshield area.

- When traveling at speeds over 37 mph (60 km/h) a constant low level tapping noise may be heard coming from the A-pillar area due to insufficient windshield molding clip tension.

- TSB JLRTB02058NAS1 is going through sign-off to provide robust repair guidance to address tapping noise concerns from the A-pillar area
- Should a customer express a concern, please refer to this TSB for guidance on repair.
