Intermittent Passive Entry Operation

20-21MY L663 Defender

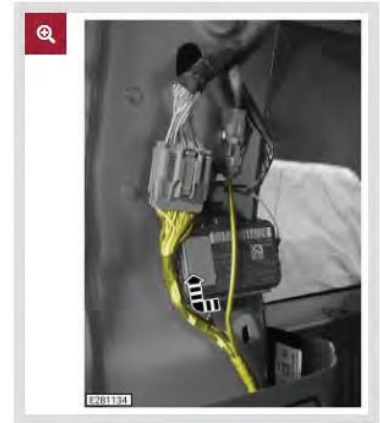
- Intermittently, the passive unlock feature does not work unless the smart key is in the customer's hand.

- Due to poor signal strength the passive entry feature may not function intermittently

- **JLRTB02076NAS1** provides instructions to relocate a new RF Receiver behind the left D-pillar trim.
- Prior to installation a link lead will need to be assembled, please refer to TOPIx Workshop Manual section 418-02: Wiring Harnesses – Description & Operation Wiring Harness to review JLR approved wiring harness repair methods.
