TECHNICAL TOPICS

Tapping Noise from A-Pillar Area

20 – 21MY Defender

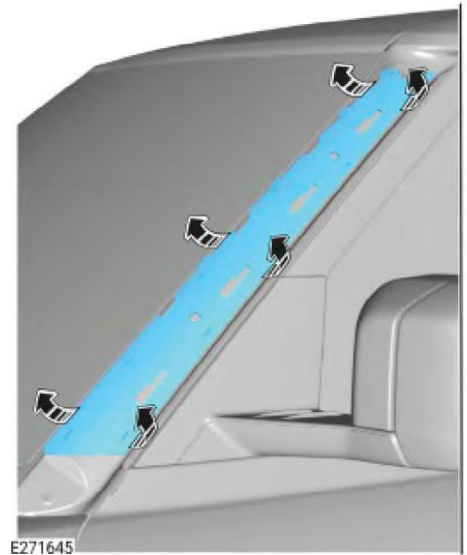
- A customer may report a tapping type noise while driving from the windshield area.

- When traveling at speeds over 37 mph (60 km/h) a constant low level tapping noise may be heard coming from the A-pillar area due to insufficient windshield molding clip tension.

- TSB **JLRTB02058NAS1** is going through sign-off to provide robust repair guidance to address tapping noise concerns from the A-pillar area
- Should a customer express a concern before this TSB is published and repair support is needed, please contact Jerry Bennett at jbenne87@jaguarlandrover.com.
