## TECHNICAL TOPICS

#### Air Conditioning Not Blowing Cool Air Into Cabin

17 – 21MY Discovery, Range Rover, RR Sport

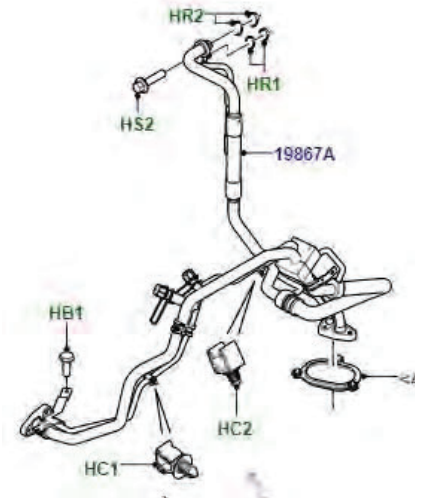
- This may be caused by an air conditioning system that is low on refrigerant due to a service port valve leak.

- Engineering is currently investigating refrigerant leaks from the service ports.
- **SSM 75302** is being published to provide requesting an EPQR be submitted with pictures and diagnosis steps performed.
- Engineering would like to get failed parts returned to support the investigation.
- Should one service port valve be found to be leaking, please recover the refrigerant in the system through the other service port to avoid disturbing the evidence of the leaking service port.
