## Technical product information

| <b>Topic</b> | Bentayga deployable sill step malfunction |
| <b>Transaction No.</b> | 2044536/9 |

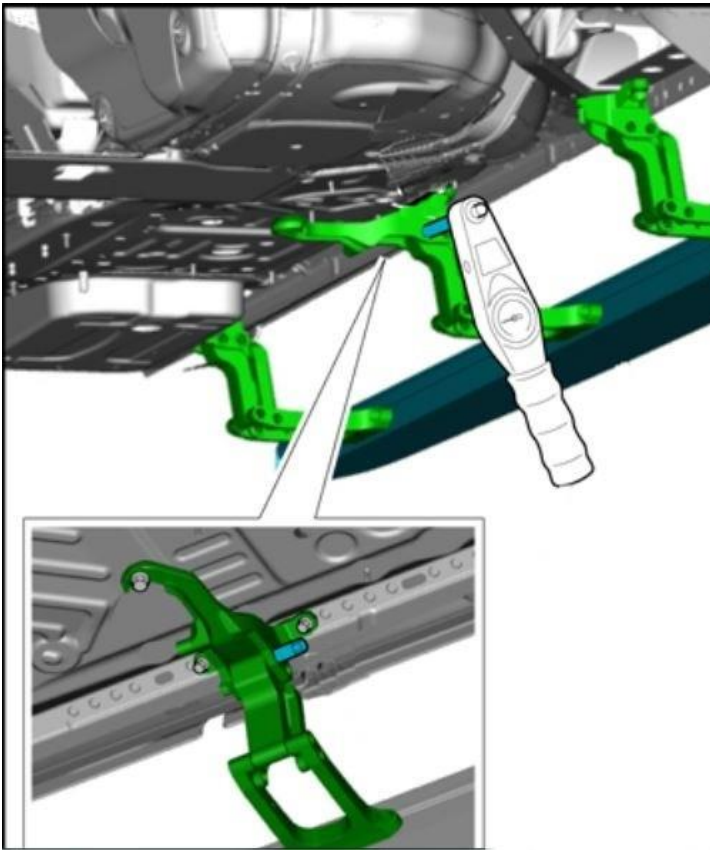
Figure 1

6. Remove both sill step motors and measure the deployment resistance – figure 1 - Refer to Repair Group 66 - Exterior equipment – Accessories – Deployable sill steps – to fit. Video the procedure and provide results.

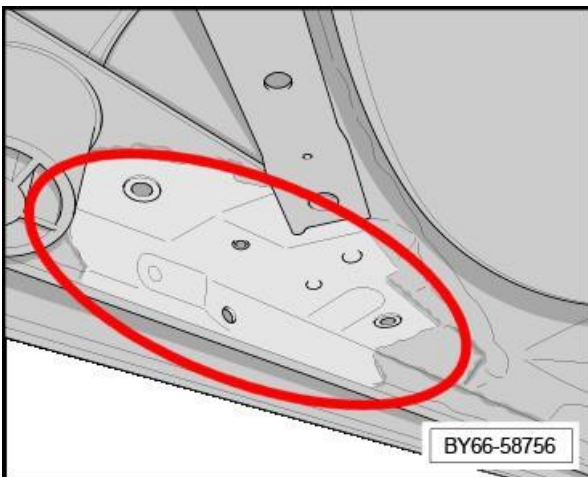
Referring to Rep.Gr 66 – Ensure the instructions are strictly adhered to, The operative **MUST** ensure the rivets/EJOT nuts below the rear hinge have been removed as failure to remove the rivets/EJOT nuts will have an effect on the operation of the sill steps

**VERY IMPORTANT:** Please ensure a Photograph of the area shown in Figure 2 is provided confirming the rivets/EJOT nuts have been removed
