Technical Service Bulletin

No:	TSB-21-52A-001	
			DATE:	March 2021	
OF GLOVE BOX				All Eclipse Cross	
CIRCULATE TO:	[] GENERAL MANAGER	[X] PARTS MANAGER		[X] TECHNICIAN	
[X] SERVICE ADVISOR	[X] SERVICE MANAGER	[] WARRANTY PROCESSOR		[] SALES MANAGER

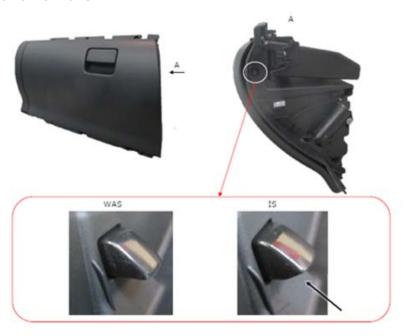
Customers may experience difficulty closing the glove box and securing the door in a closed position. The hook side of the locking mechanism may not properly latch when pushing the glove box door closed from the front. Over time improper closure and latching may create a deformity and as a result, the glove box may become more difficult to close.

In November 2020, the shape of the claw edge of the glove box locking mechanism was changed permitting easier glove box closure.

Replace the old part with a new one.
