# Technical Service Bulletin

HOOD LATCH & BUMPER HEIGHT ADJUSTMENT			No:	TSB-21-42A-001
			DATE:	March 2021
			MODE	All 2022 Outlander
CIRCULATE TO:	[ ] GENERAL MANAGER	[X] PARTS MANAGER		[ <b>X</b> ] TECHNICIAN
[X] SERVICE ADVISOR	[X] SERVICE MANAGER	[ ] WARRANTY PROCESSOR	7	[ <b>X</b> ] SALES MANAGER

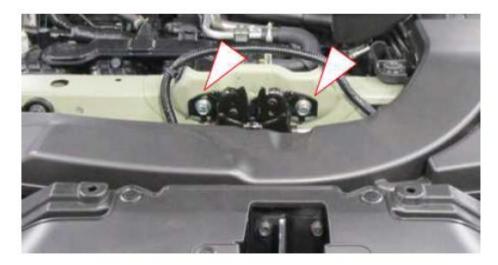
A hood flutter may occur on 2022 Outlanders. This is caused by improper Hood Latch and Bumper height alignment.

3. Loosen 2 bolts which secure the Latch to the Body and move Latch down to its lowest position.

- 4. Fasten 2 bolts with fixing torque 22Nm and loosen by 1 revolution.
  - a. Drop the Hood from the height of 100mm for the for centering of the Latch.
  - b. Open the Hood and fasten 2 bolts with fixing torque 19 -22Nm to secure the Latch.
  - c. Install the Latch Cover with 2 bolts, fixing torque 4 -6Nm.
  - d. Install the Upper Bar Cover with 10 clips.
