## Technical product information

<b>Topic</b>	Various and/or numerous Transmission control module DTC's logged - V8 Kovomo engine
<b>Market area</b>	Russische Föderation (5RU),Australia E04 Bentley rest Asia and Australia (6E04),China 796 VW Import Comp. Ltd (Vico), Beijing (6796),Germany E02 Bentley rest Europe (6E02),Japan E03 Bentley Japan (6E03),Korea, (South) E08 Bentley South Korea (6E08),United Arab Emirates E06 Bentley Middle East and Africa (6E06),United Kingdom E01 Bentley UK (6E01),United States E05 Bentley USA and rest America (6E05)
<b>Brand</b>	Bentley
<b>Transaction No.</b>	2061288/3
<b>Level</b>	EH
<b>Status</b>	Approval
<b>Release date</b>

### New Continental GT/GTC - New Flying Spur - V8 Kovomo

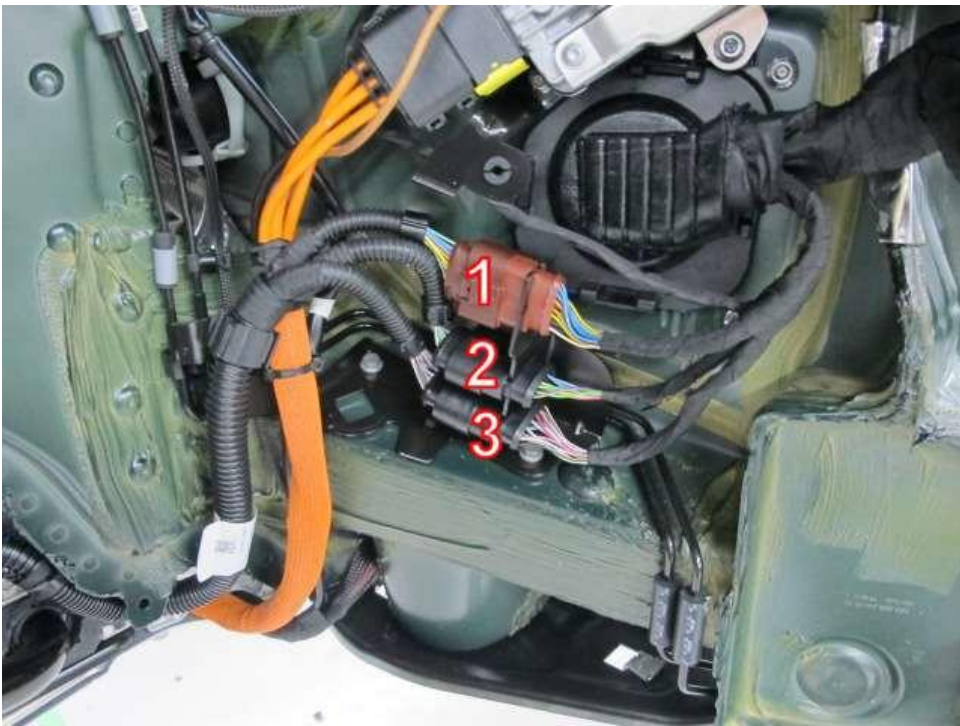
Loose pins within the transmission link harness to the Mechatronic unit for dual clutch gearbox -J743- connections can lead to various and/or numerous Transmission control module DTC's being logged

- Referring to Figure 2 - Disconnect the three connectors shown

2) Once disconnected carry out pin/terminal grab checks on all three male and female connections

- In the event the main vehicle harness pins are not to specification the applicable pins should be replaced
- Should any issues be found with the transmission link harness and/or pins – the harness should be replaced
- **IMPORTANT NOTE:** In the event the pins are to specification or the applicable repairs have been done (for example - Harness replacement or pin replacement) - Reconnect all three connectors (Figure 2) and proceed to Step 3
