Field campaign

Topic	Bentayga Speed - SVM update for Address 0017 - Dash Board - During PDI (SC 21/12)
Market area	Russische Föderation (5RU),Australia E04 Bentley rest Asia and Australia (6E04),Germany E02 Bentley rest Europe (6E02),United Arab Emirates E06 Bentley Middle East and Africa (6E06),United Kingdom E01 Bentley UK (6E01),United States E05 Bentley USA and rest America (6E05)
Brand	Bentley
Transaction No.	2062667/1
Campaign number	EB93
Note	
Type	
US code

Bentayga Speed

Software update required to diagnostic address 0017 – Dash Board

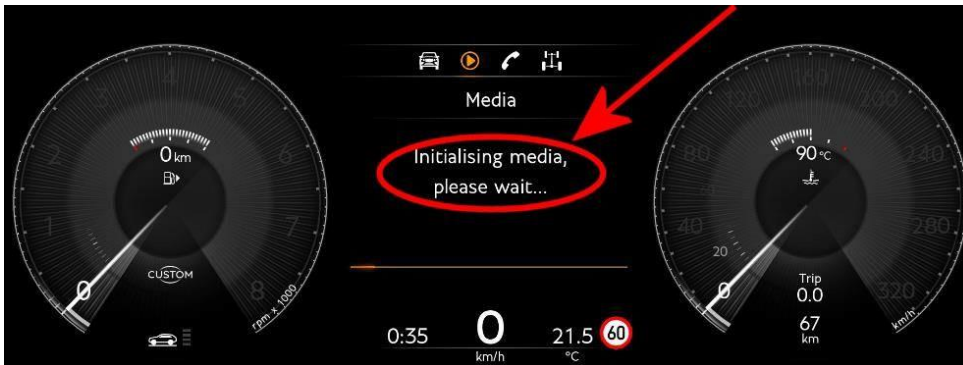
The update is required to eliminate a communication related message from appearing within the DIP as shown in Figure 1

SVM coding is now available for address 0017 – Dash Board

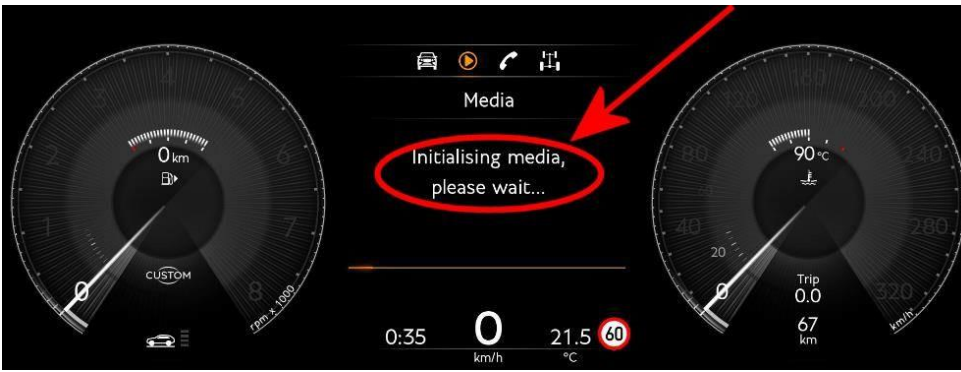
The update is required to eliminate a communication related message from appearing within the DIP as shown in Figure 1
