SERVICE BULLETIN

Classification: AN13-035C	Reference: NTB13-085C	Date: March 11, 2021
------------------------------	--------------------------	-------------------------

2014-2015 ALTIMA & 2014 ROGUE; AUDIO VISUAL SYSTEM SOFTWARE UPDATE

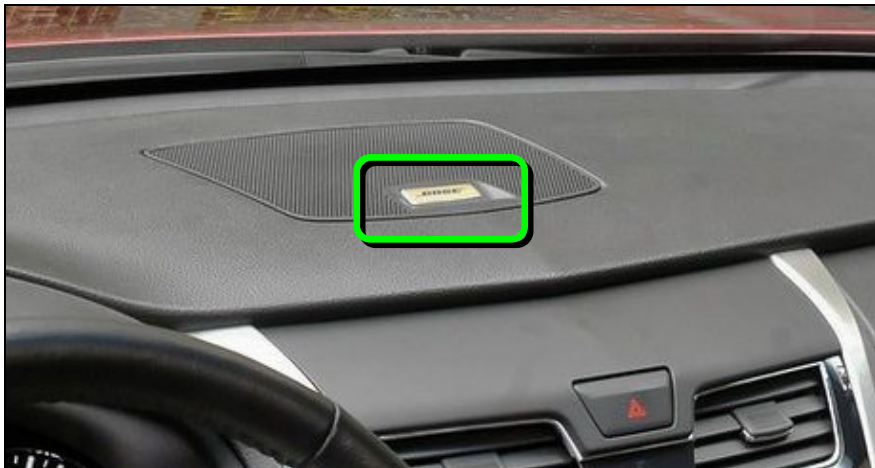
Figure 1

Altima: Check if the audio system is BOSE® (see Figure 1):

- **Non-BOSE:** Use USB Flash Memory #1.
- **With BOSE:** Use USB Flash Memory #2.

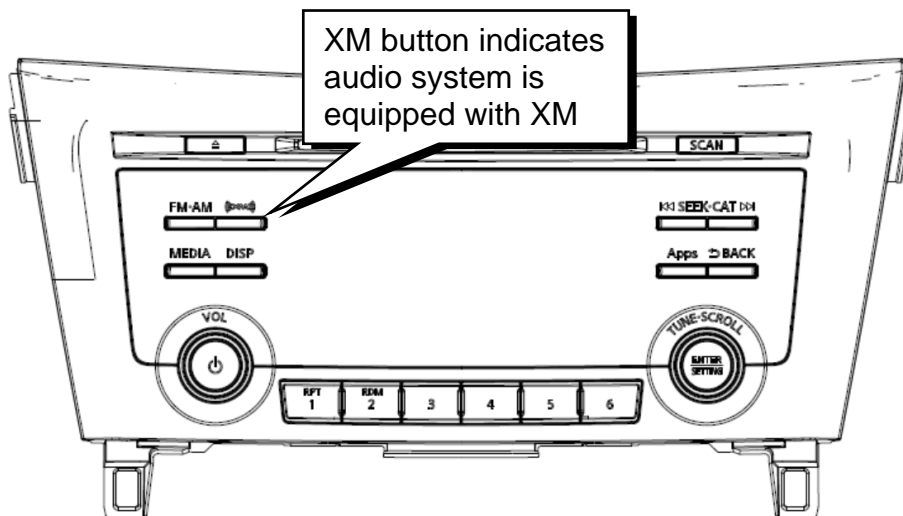
Figure 2

Rogue: Check if the audio system is equipped with XM radio (see Figure 2).

- **With XM:** Use USB Flash Memory #3.
- **Non-XM:** Use USB Flash Memory #4.

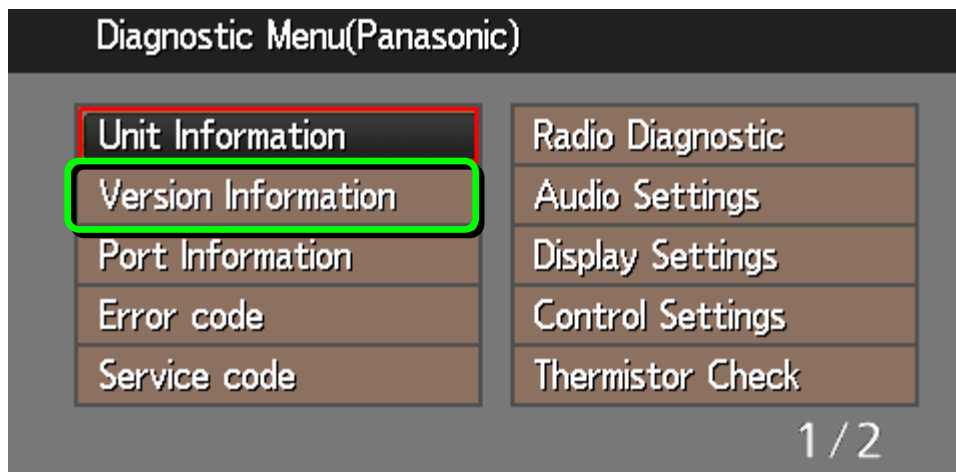
Figure 3

8. Make sure the audio system is turned OFF.
9. Access the **Diagnostic Menu(Panasonic)** as follows:
 - a. Press and hold down preset buttons 2 and 3.
 - b. While holding preset buttons 2 and 3, press preset button 5 more than 3 times, until the screen in Figure 3, below, displays.
10. Select **Version Information** (Figure 3).

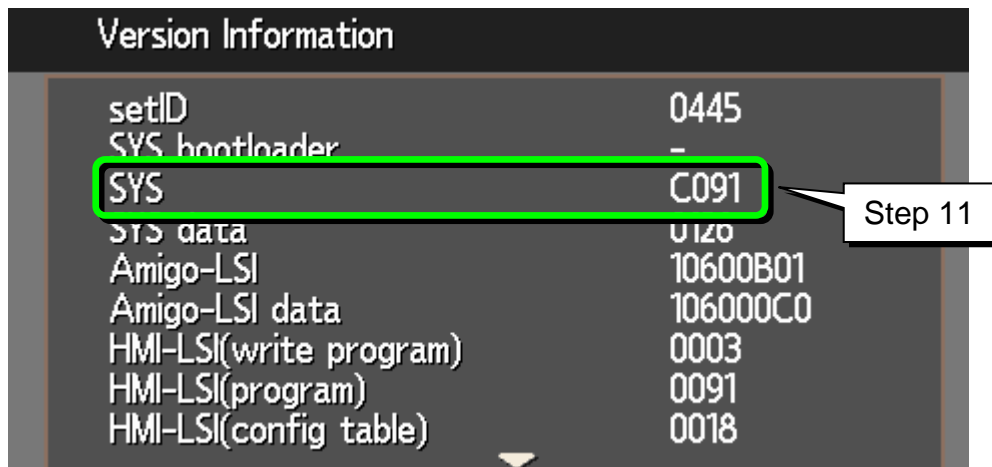
Figure 4

11. Check the **SYS** version number (Figure 4). It should **NOT** be "5091".

IMPORTANT: If the **SYS** version is "5091" this bulletin does not apply. Refer to ASIST for further diagnostic and repair information.

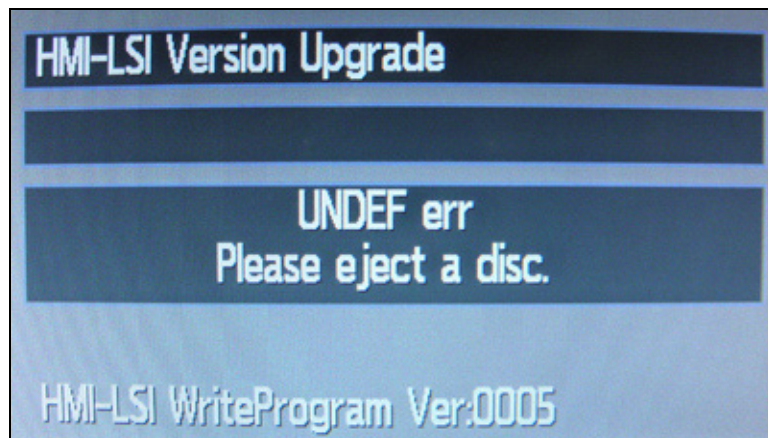
Figure 5

- Do not turn the ignition OFF or remove the USB Flash Memory while the software update is in progress.
- Do not remove the USB Flash Memory when “**UNDEF err Please eject a disc**” is displayed (see Figure 5).

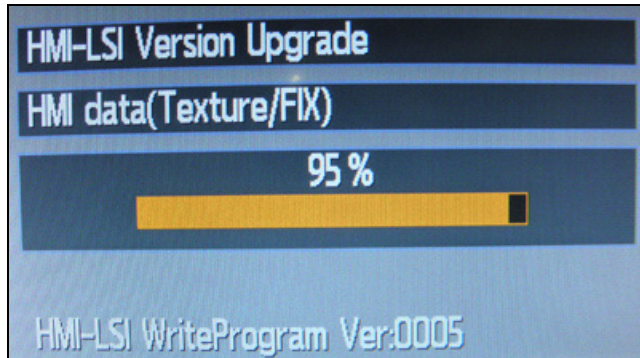
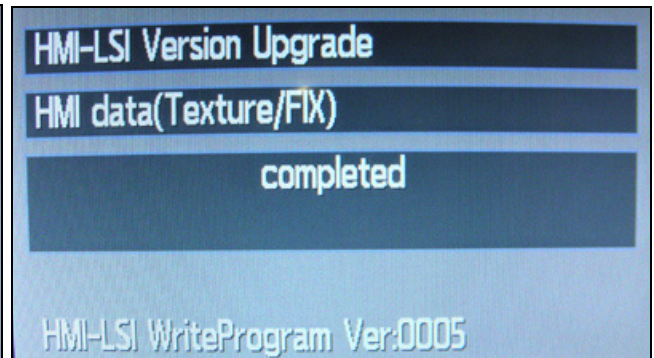
- During the entire software update, 2 to 5 individual sub-upgrades will be displayed, each with a progress bar and then a “completed” screen (examples shown in Figures 6 and 7).
- Between each individual sub-upgrade, an audible “pop” will be heard through the speakers.

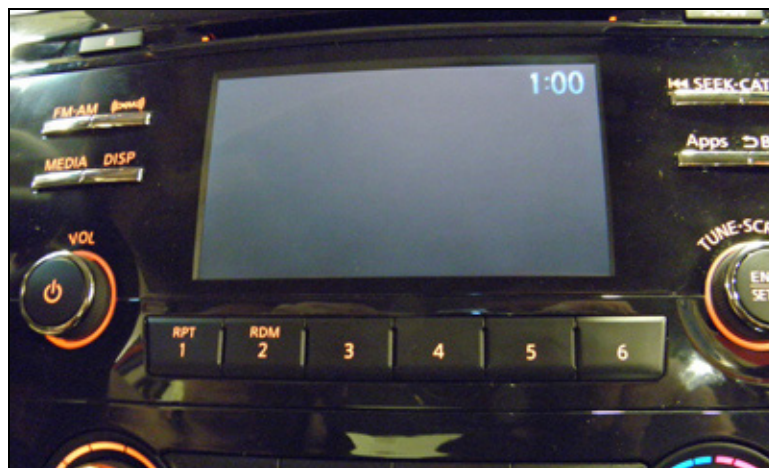
Figure 8

- A long beep will sound, and
- The audio OFF screen (blank with clock) will be continuously displayed (see Figure 8).

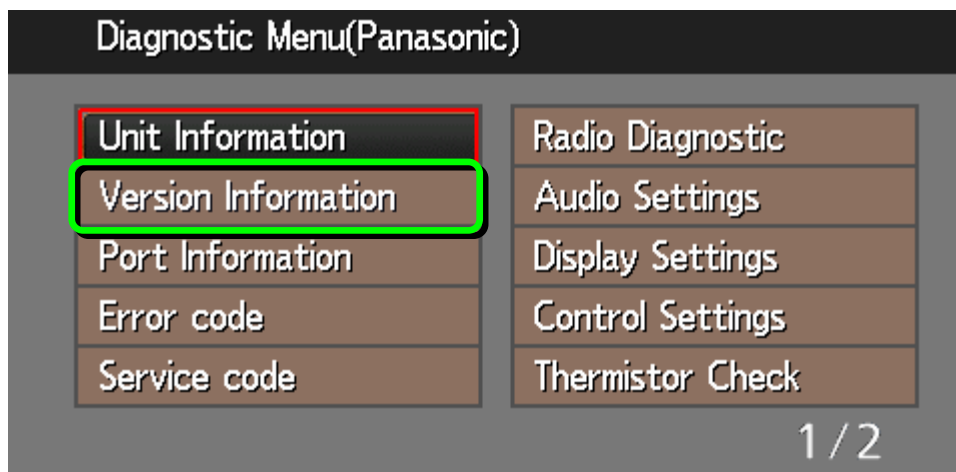
- a. Turn the ignition ON.
- b. Make sure the audio system is OFF.
- c. Press and hold preset buttons 2 and 3.
- d. While holding preset buttons 2 and 3, press preset button 5 more than 3 times, until the screen in Figure 9 displays.
- e. Select **Version Information** (see Figure 9).

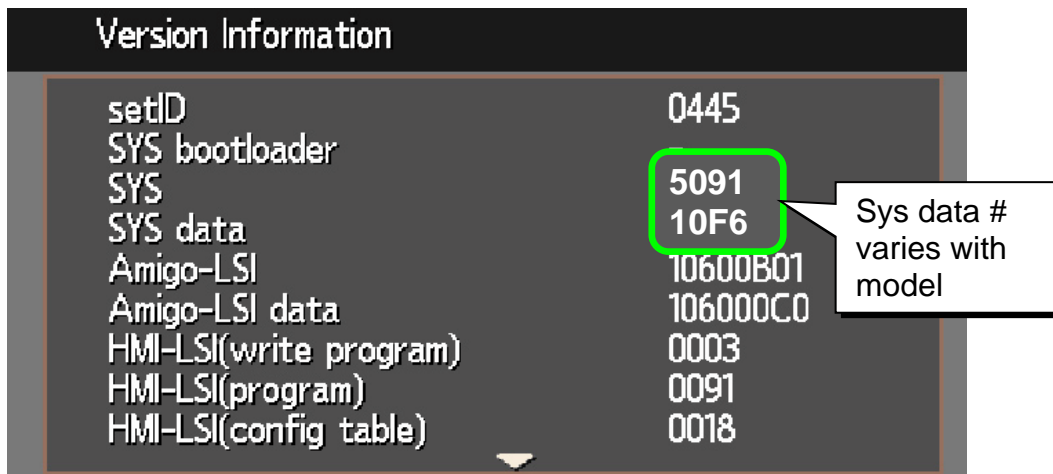
Figure 10

- f. Verify the **SYS** version and **SYS data** version (Figure 10) are correct as follows:

Model	Option	SYS	SYS data
2014-2015 Altima	Non-BOSE	5091	10F6
	With BOSE	5091	11F6
2014 Rogue	Without XM/APPS	5091	02F6
	With XM/APPS	5091	04F6

- If the version numbers are not correct, confirm the correct USB Flash Memory was used and perform steps 12 through 21 again.
