SERVICE BULLETIN

Classification: AN15-016C	Reference: NTB15-066C	Date: March 23, 2021
------------------------------	--------------------------	-------------------------

2015 MURANO; AV CONTROL UNIT AND A/C SWITCH ASSEMBLY SERVICE INFORMATION

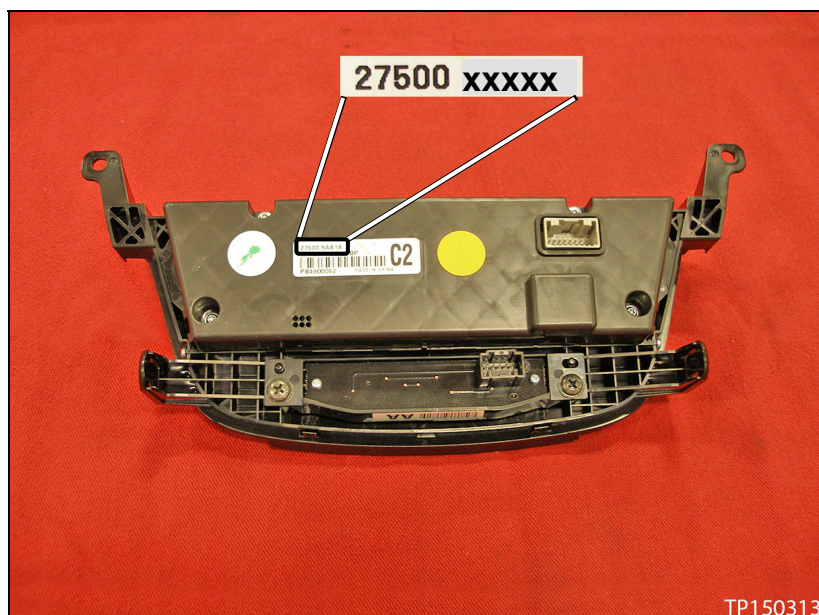
Figure 1: Location of A/C switch assembly P/N

Whenever an AV control unit on an applied vehicle is replaced for any reason, check the part number (P/N) of the A/C switch assembly (A/C Controller Assembly).

- If the P/N is 27500-5AA1**A**, replace the A/C switch assembly with 27500-5AA1**C**.
- If the P/N is NOT 27500-5AA1**A**, do NOT replace the A/C switch assembly.

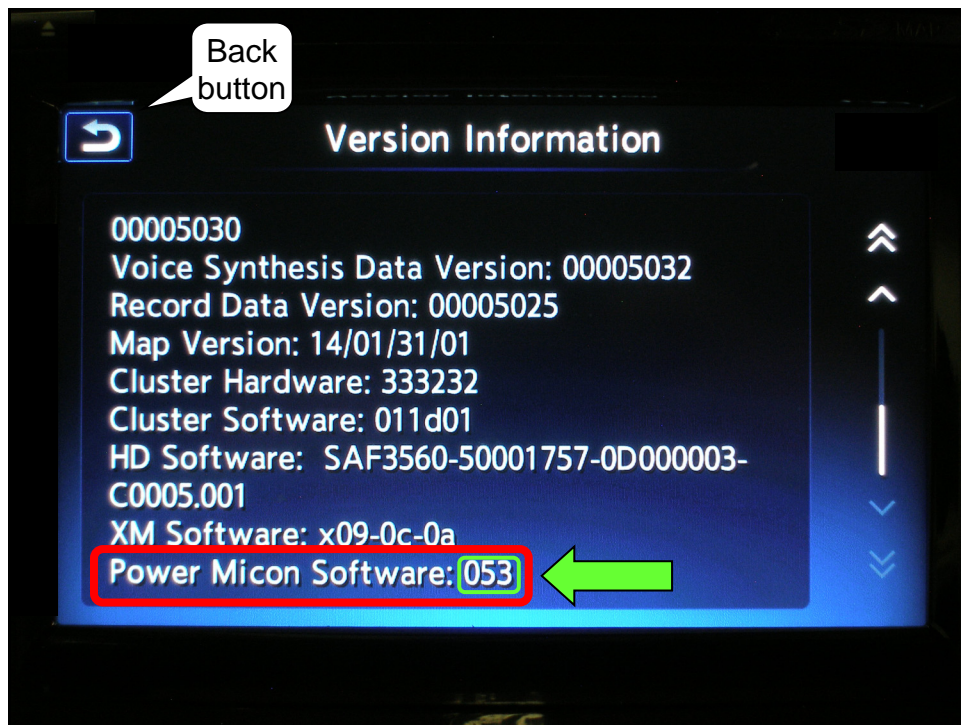
Figure 5

6. Check the software number next to **Power Micon Software**.
 - If **054** or higher, a software update is not needed, or has been successfully performed.
 - If less than **054**, a software update needs to be performed.
 - If a software update needs to be performed, leave the screen as is, and then go to page 6, **AV Control Unit Software Update with Software Update SD Card**.
