MODEL  
2020-2021MY  
Telluride (ON)

NUMBER  
231

## TECHNICAL SERVICE BULLETIN

**FRONT VIEW CAMERA REPLACEMENT  
FOR DTC C160449 & C160649**

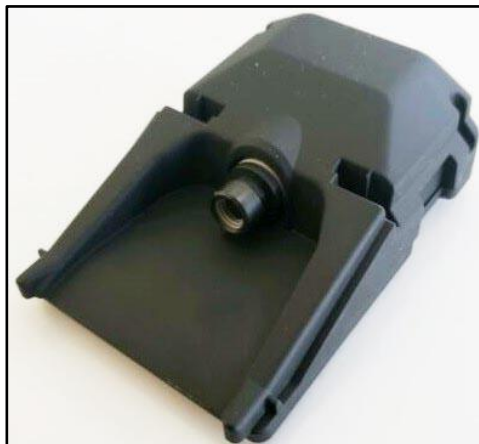
Front View Camera

This bulletin provides information on the inspection and replacement of the front camera on some 2020-2021MY Telluride (ON) vehicles, produced from August 7, 2018 through November 30, 2020. Due to an internal control chip concern inside the camera, the vehicle may exhibit an MIL on with DTC C160449 and/or C160649, as well as illumination of the Smart Cruise Control (SCC), Lane Keep Assistance (LKA), Lane Departure Warning (LDW), Forward Collision-Avoidance Assist (FCA), Forward Collision Warning (FCW) and/or Driver Attention Warning (DAW) lights. These systems may become temporarily disabled during occurrences. Follow the procedure outlined in this publication to diagnose and replace the front view camera assembly.

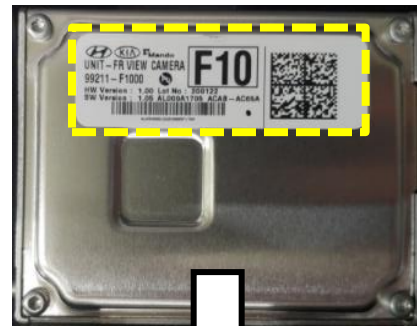
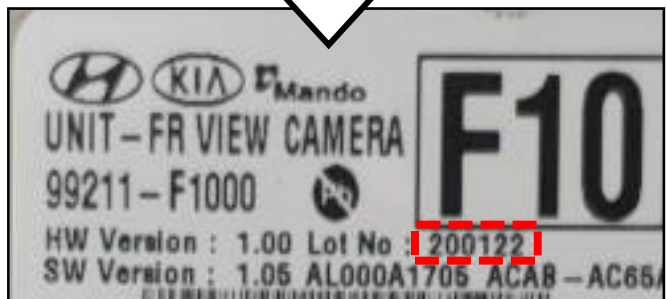
- **Telluride (ON):** Improved Lot is from June 7, 2019 and later.

- 1b. Confirm the lot numbers of the new units as shown. Manufacturing date code is “YYMMDD”.
