Classification:
AN20-026BReference:
ITB20-021BDate:
March 15, 2021

SOFTWARE UPDATE FOR INFOTAINMENT ISSUES

APPLIED VEHICLES: 2020-2021 Q50 (V37)
2020-2021 Q60 (CV37)
2020-2021 QX50 (J55)
2020-2021 QX80 (Z62)

APPLIED SYSTEM: Audio Infotainment System

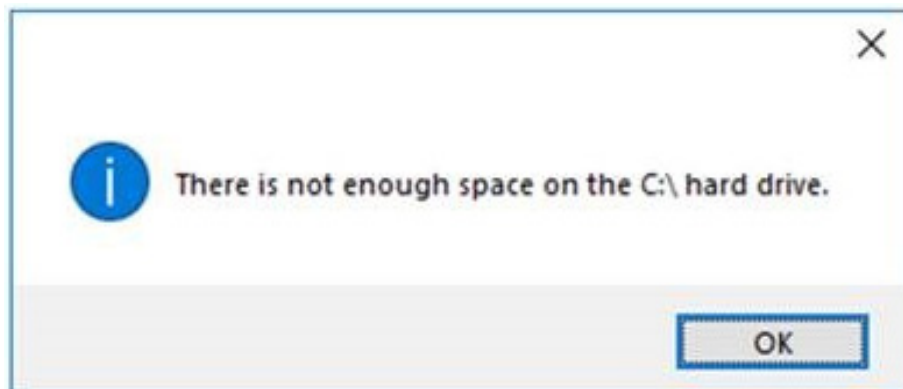
Figure 8

- The update is estimated to take **6 hours** to download to the USB drive.
- If while attempting to download the update-software to the ASIST Station, you receive the message shown in Figure 8:
 - a. First attempt to clear space on the ASIST station hard drive (40 GB required).
 - b. If space cannot be cleared and a second CONSULT PC\Unit is available with space, use it and start over from step 5.
 - c. If a second CONSULT PC\Unit is not available, and space on the hard drive cannot be cleared, email Bosch at nissan.dealers@us.bosch.com for additional options.
