SERVICE BULLETIN

TF15-001A

2013 – 2014 PATHFINDER 4WD ERROR DISPLAYED AND DTC C1204 STORED

APPLIED VEHICLES: 2013 – 2014 Pathfinder (R52) } Equipped with 4WD
2014 Pathfinder Hybrid (R52) }

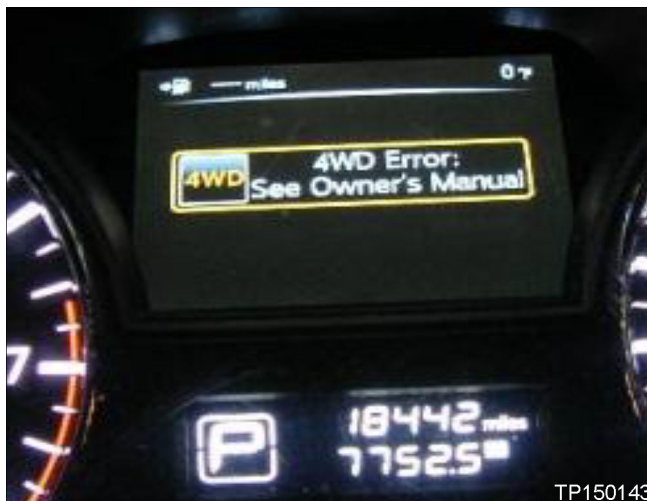
Figure 1

“4WD ERROR” is displayed in the Vehicle Information Display,

DTC C1204 (4WD Solenoid) is stored.

Replace the 4WD Control Unit.
