# SERVICE BULLETIN

Classification: EC20-031A	Reference: NTB21-001A	Date: March 30, 2021
------------------------------	--------------------------	-------------------------

## 2020-2021 TITAN/TITAN XD; TCM COMMUNICATION ERROR CAUSING A NO START CONDITION

**APPLIED VEHICLES:** 2020-2021 Titan/Titan XD (A61)

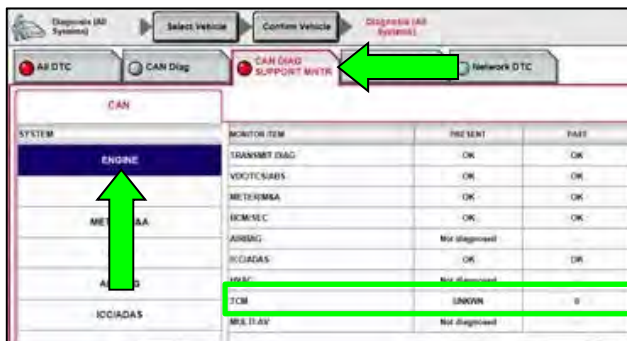
There is a U0101 DTC (Lost Comm TCM) in the Engine Control Unit (ECU) and/or the Shifter Control Unit (SCU). This DTC may be in a PAST or CURRENT status.

The TCM shows “UNKWN” in the **PRESENT** column or “0” in the **PAST** column under the **CAN DIAG SUPPORT MNTR** tab within the ECU (**ENGINE**) or the SCU (**SHIFT**) in CONSULT-III PLUS (C-III plus). See Figure 1 and Figure 2.

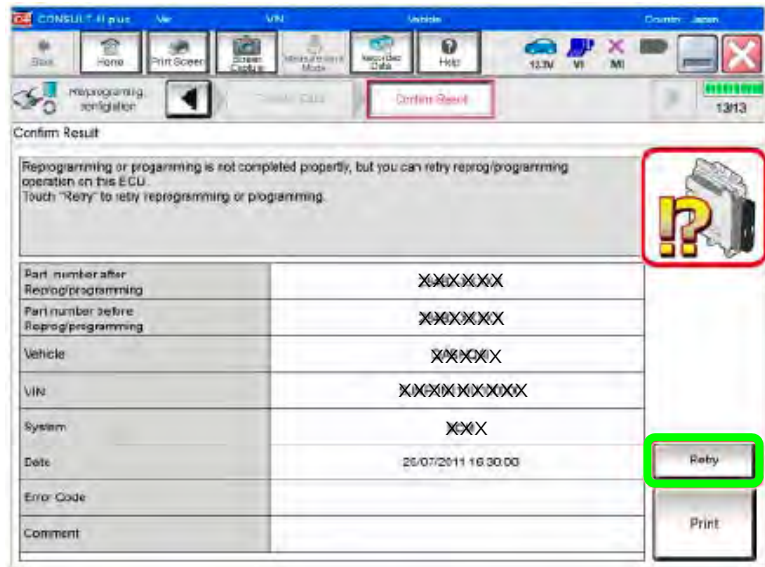
Figure 18

If reprogramming does not complete and the “!?” icon displays as shown in Figure 18:

- Check battery voltage (12.0 V – 15.5 V).
- Ignition is ON, engine is OFF.
- External Bluetooth® devices are OFF.
- All electrical loads are OFF.
- Select retry and follow the on screen instructions.
- “Retry” may not go through on first attempt and can be selected more than once.

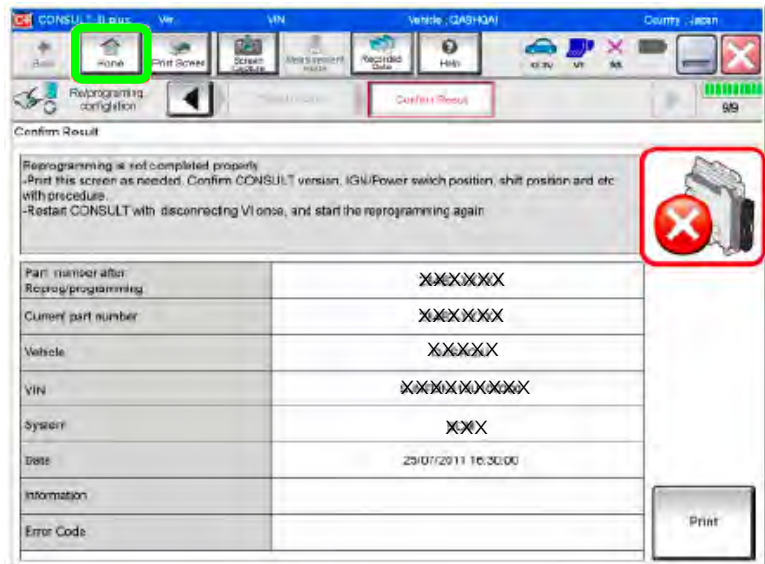
Figure 19

If reprogramming does not complete and the “X” icon displays as shown in Figure 19:

- Check battery voltage (12.0 V – 15.5 V).
- CONSULT A/C adapter is plugged in.
- Ignition is ON, engine is OFF.
- Transmission is in Park.
- All C-III plus / VI cables are securely connected.
- All C-III plus updates are installed.
- Select Home, and restart the reprogram procedure from the beginning.

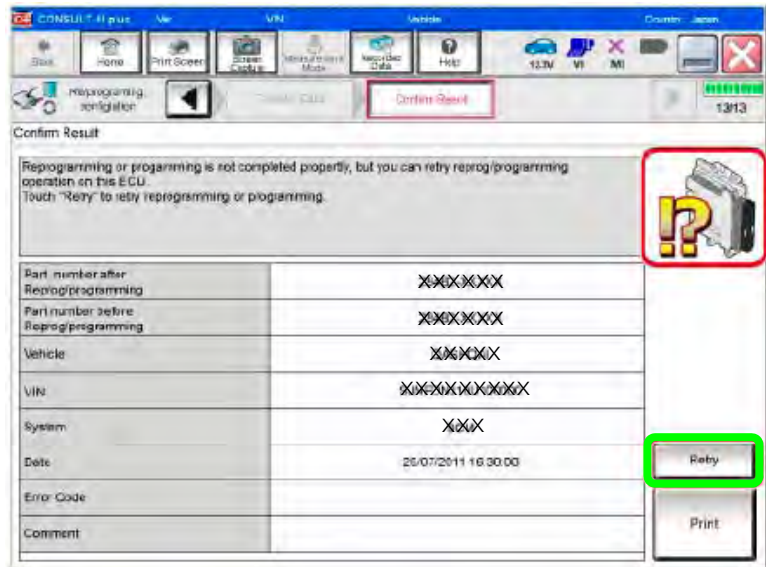
Figure 28

If reprogramming does not complete and the “!?” icon displays as shown in Figure 28:

- Check battery voltage (12.0 V – 15.5 V).
- Ignition is ON, engine is OFF.
- External Bluetooth® devices are OFF.
- All electrical loads are OFF.
- Select retry and follow the on screen instructions.
- “Retry” may not go through on first attempt and can be selected more than once.

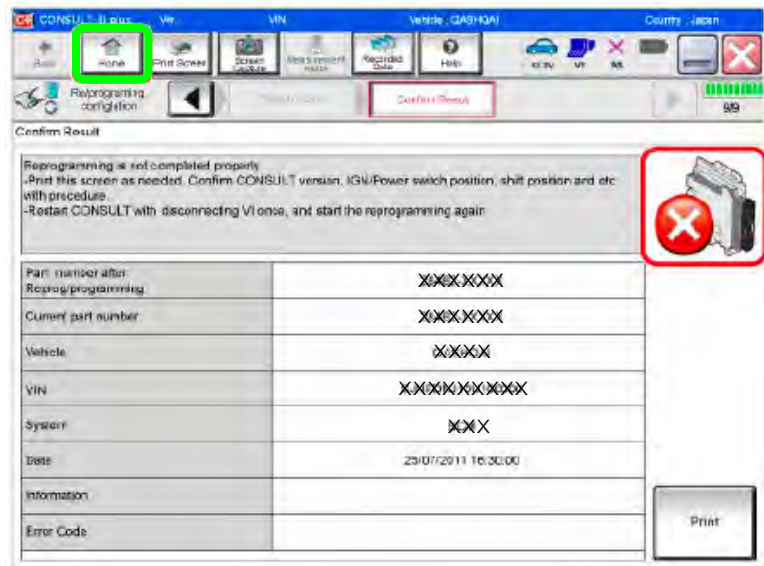
Figure 29

If reprogramming does not complete and the “X” icon displays as shown in Figure 29:

- Check battery voltage (12.0 V – 15.5 V).
- CONSULT A/C adapter is plugged in.
- Ignition is ON, engine is OFF.
- Transmission is in Park.
- All C-III plus / VI cables are securely connected.
- All C-III plus updates are installed.
- Select Home, and restart the reprogram procedure from the beginning.
