Technical Service Bulletin

2062929/1

69-21-01 – Friction Related Click or Pop Noise from Steering Column

4/7/2021

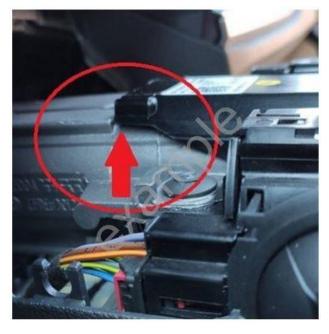
Figure 2:

Inspect the installation of the Steering Column Electronics Control Module -J527- (steering column combination switch) at the steering column upper housing.
