Technical Service Bulletin

15 Oil leak from the cylinder head - 2.9 and 3.0TFSI only

15 21 38 2053278/7 April 1, 2021. Supersedes Technical Service Bulletin Group 15 number 21-37 dated February 16, 2021 for reasons listed below.

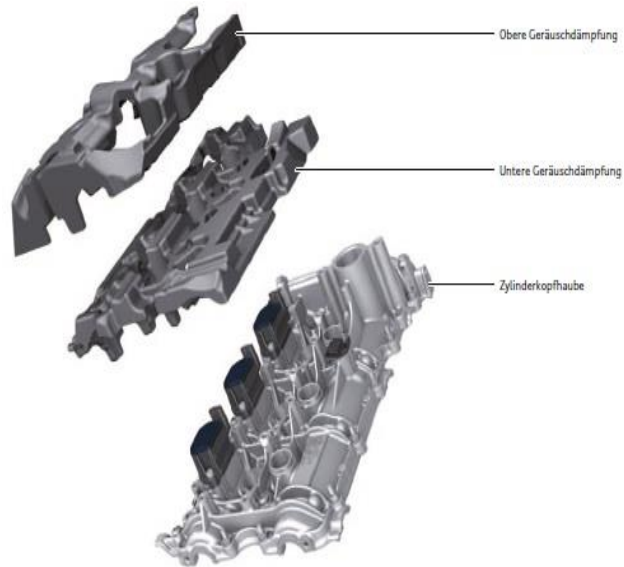
Figure 1. Removing the upper noise insulation.

2. Remove the upper noise insulation of the affected cylinder bank (Figure 1).

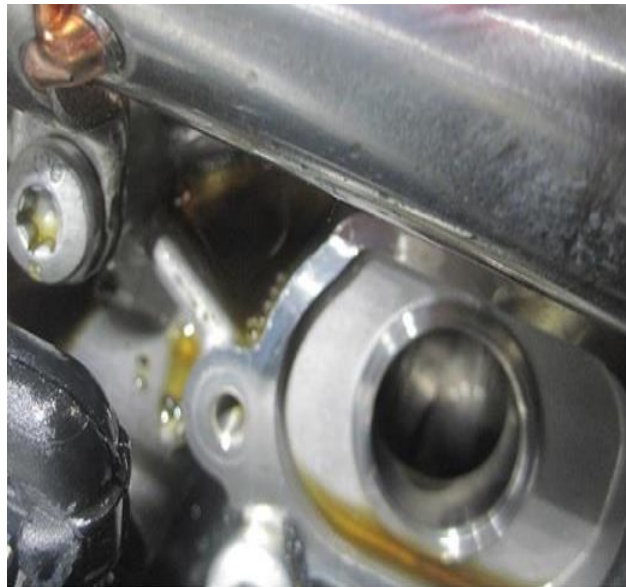
A. If there is a substantial quantity of oil below the Audi valvelift system actuator (illustration), the cause of the leak is the O ring of the Audi valvelift system actuator.

Figure 2. Oil in the Audi valve lift system.

Replace the Audi valvelift system actuator with an O ring, clean the engine compartment, and if necessary replace the noise insulation (if it is soaked in oil) (Figure 2).

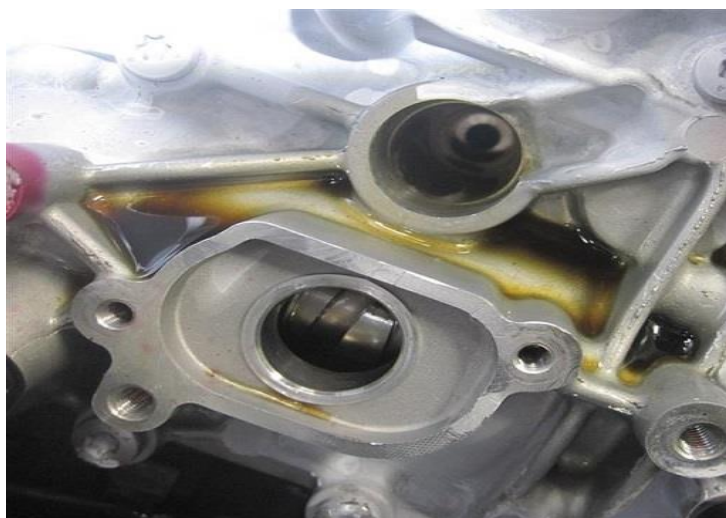
4. Remove the lower noise insulation.
5. Locate the affected cylinder. Oil should have gathered in the area of the injector (Figure 3) and the noise insulation should also be soaked in oil.

Figure 3. Locating the affected cylinder.

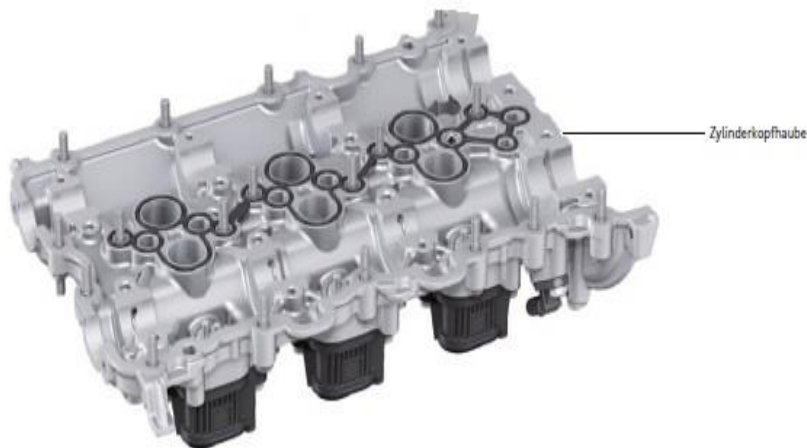
Figure 4. Remove the cylinder head cover and gasket.

6. Remove the cylinder head cover and the seal (Figure 4).

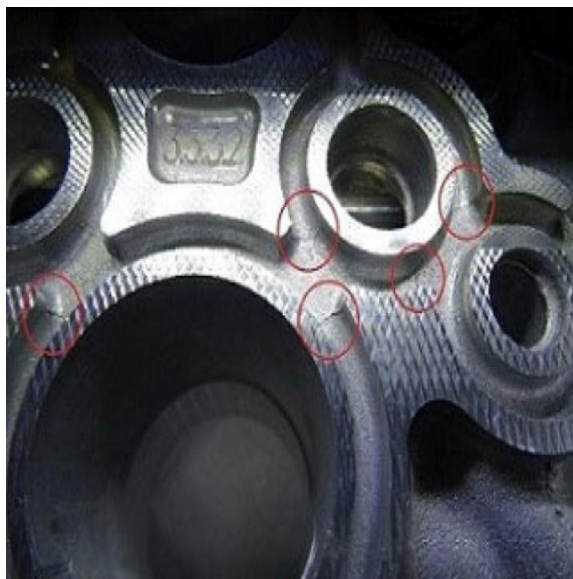
Metal shavings produced during manufacture in sealing groove between cylinder head cover and the cylinder head.

Figure 5. Before the repair.

7. Inspect the gasket groove in the cylinder head cover and remove any casting residues with a suitable tool (Figure 5). The residues can be removed with a small flat screwdriver (Figure 6).

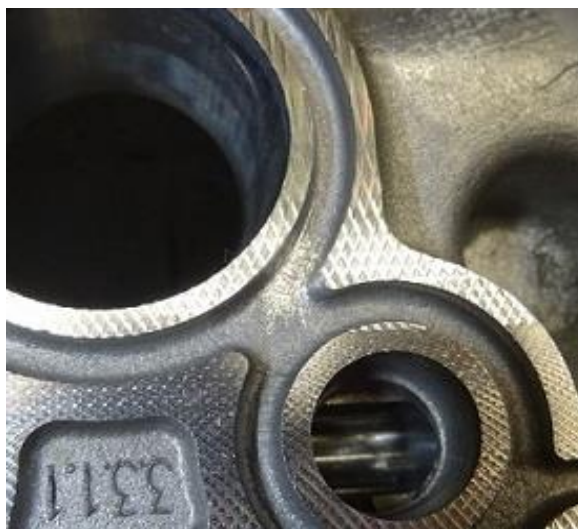
Figure 6. After the repair.

8. Install a new seal, re-assemble the camshaft cover, clean the engine compartment, and if necessary replace the noise insulation (if it is full of oil).
