19 Coolant leak in area of coolant thermostat housing/coolant pump - 2.0TFSI

19 21 15 2061604/3 April 1, 2021. Supersedes Technical Service Bulletin Group 19 number 21-14 dated March 8, 2021 for reasons listed below.

Model(s)	Year	VIN Range	Vehicle-Specific Equipment
А3	2007 - 2013	All	Evo2
A4	2007 - 2016	All	Evo2
A5	2010 - 2016	All	Evo2
A6	2012 -2015	All	Evo2
A8	2013	All	Evo2
Q3	2012 - 2018	All	Evo2
Q5	2011 - 2017	All	Evo2
TT	2009 - 2014	All	Evo2

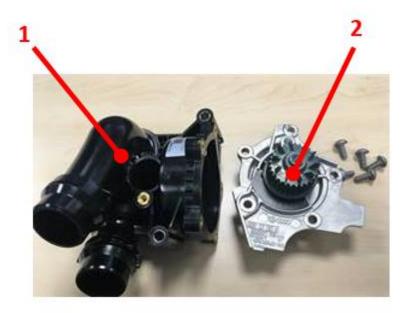
Coolant loss from the coolant thermostat housing (Figure 1, position 1) or the coolant pump (Figure 1, position 2).

Figure 1. Coolant thermostat/coolant pump. Parts are available separately, see parts table below.

Only replace the leaking component (coolant pump or coolant thermostat housing).

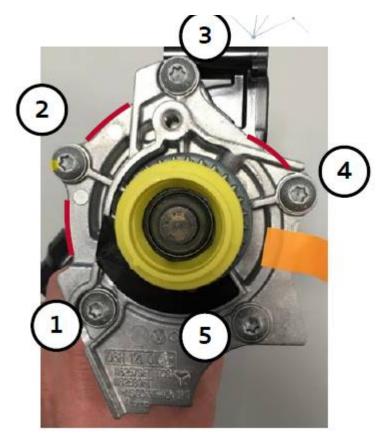
Figure 2. Securing bolts of the coolant pump (1 to 5).

- Assemble the coolant thermostat housing and the coolant pump and attach the five connecting bolts.
 - Align the two components against one another in such a way that both components are flush to one another in the areas marked in red (Figure 2). The thermostat housing must not be higher/lower than the coolant pump (run your finger over the three areas to check).

- Torque the connecting bolts of the two components to 10 Nm.

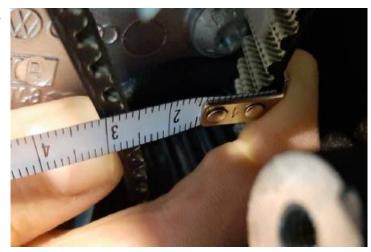
Figure 3. Checking the toothed belt tension.

5) Check the toothed belt tension (Figure 3) by pressing the toothed belt together centrally between the two toothed belt sprockets. The measured distance of the backs of the toothed belt should be between 28mm and 30mm. A measuring caliper can also be used for toothed belt compression and measurement.
