# Technical Service Bulletin

## 55 Guide to finding water ingress on the rear lid structure

55 21 55 2060265/2 April 7, 2021. Supersedes Technical Service Bulletin Group 55 number 20-48 dated August 4, 2020 for reasons listed below.

Model(s)	Year	VIN Range	Vehicle-Specific Equipment
A6 allroad, RS6 Avant	2020 - 2022	All	Not Applicable

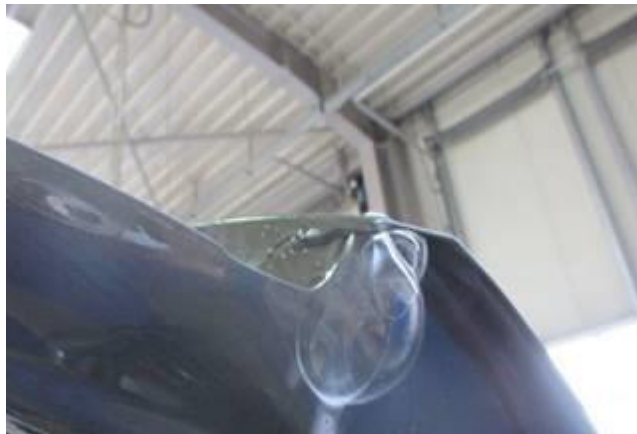
1. Remove the rear lid trim and perform a leak test on the rear lid. With the lid trim removed visual and physical access to the rear lid structure can be gained. Mix a solution of dish detergent and water and add to a spray bottle. Spray the solution on the area shown in Figure 1 while blowing compressed air from the inside of the rear lid structure and watch for bubble formation.

**Figure 1.** Bubble formation with compressed air applied internally.

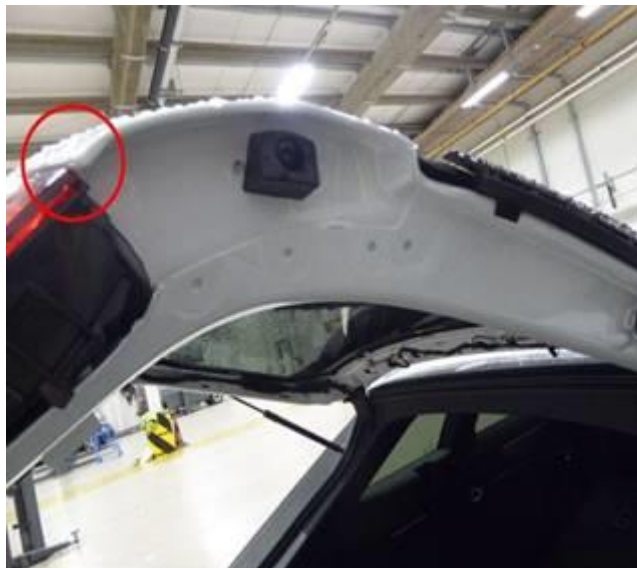
The seam sealer used to seal adjoining panels may have a flaw causing a small opening that can allow water to enter the rear lid shell. This TSB shows areas of the rear lid shell where sealer flaws may exist.

2. Should bubbles form in this area, Figure 2 shows the area where the body sealant may be flawed.

**Figure 2.** Area where sealer flaw is likely.

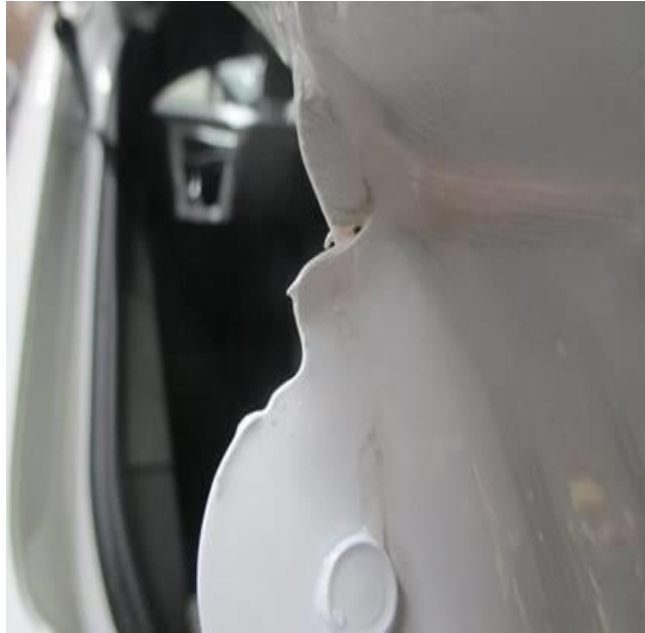
3. When the tail lamp is removed the sealer flaw can be found.

*Figure 3. Possible sealer flaw area behind tail lamp.*

7. In cases where the sealer flaw is located in a concealed area (e.g. behind a tail lamp) the openings can be repaired by applying D 511 500 A2 1k adhesive sealant to the openings with a brush. To the corresponding area on the inside of the rear lid shell apply D 321 M16 M2 cavity preservative using a brush. Ensure the application area is thoroughly clean and allow the sealant to cure as instructed. Touch up painted surfaces as necessary.

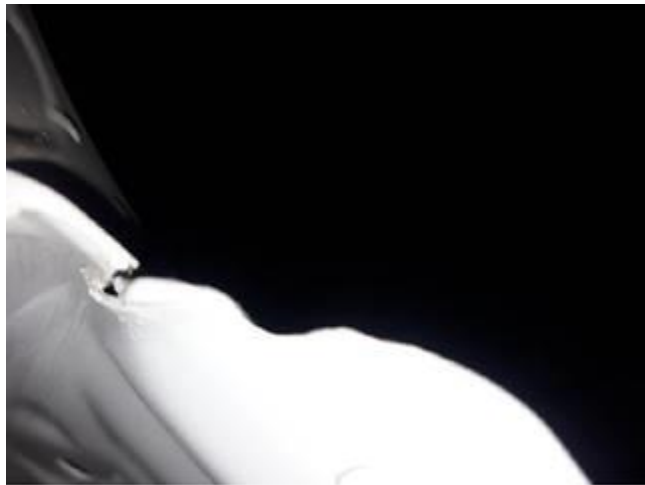
*Figure 4. Close up view of sealer flaw.*

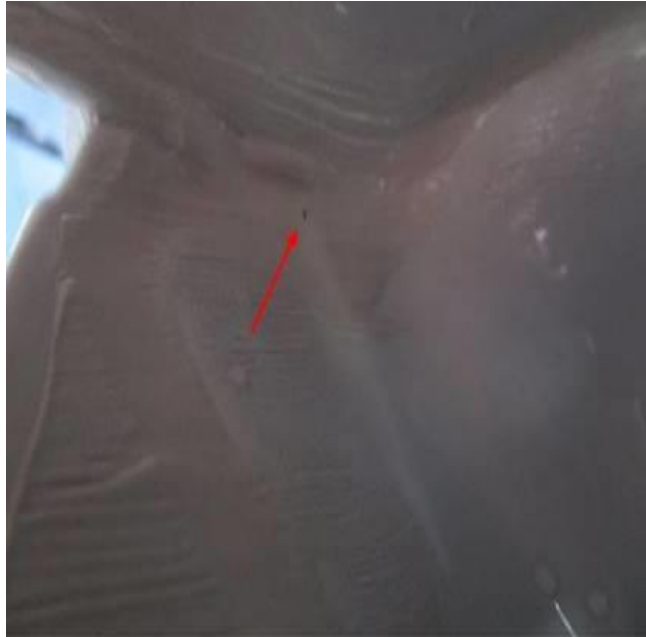
4. Figure 5 shows another possible area where a sealer flaw can be found. The holes or gaps can be very small yet allow water ingress.

*Figure 5. Another area of a possible flaw.*

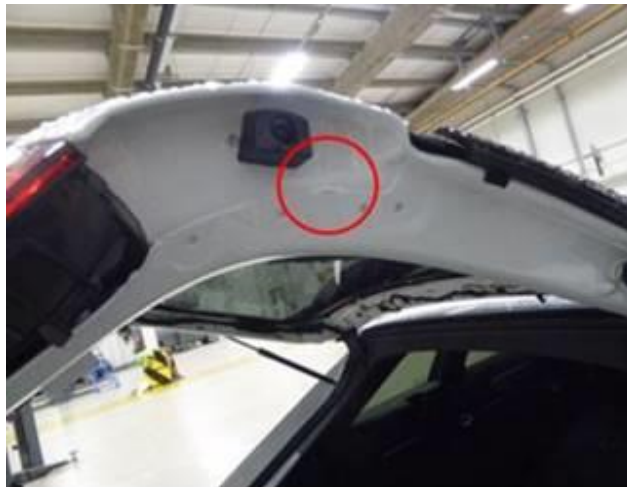
5. The flaws may not be limited to the rear tail lamp recesses but can be found along the side of the rear lid structure.

*Figure 6. Sealer flaw on side of rear lid.*

8. If the sealer flaw is in a visible area send the vehicle to your bodyshop for repair as finish paintwork will be required.

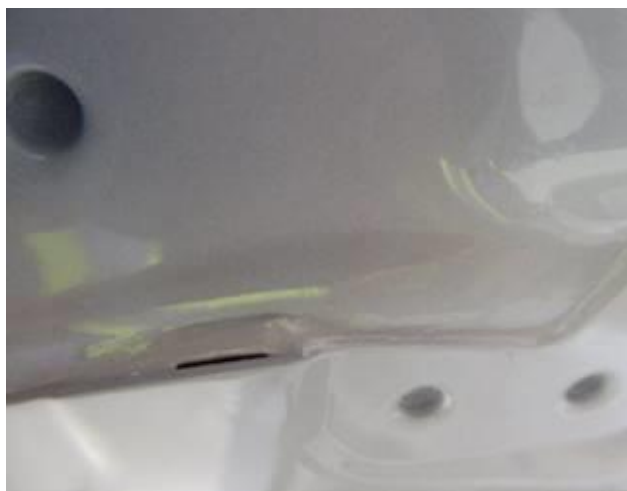
**Figure 7.** Close up view of the sealer flaw.

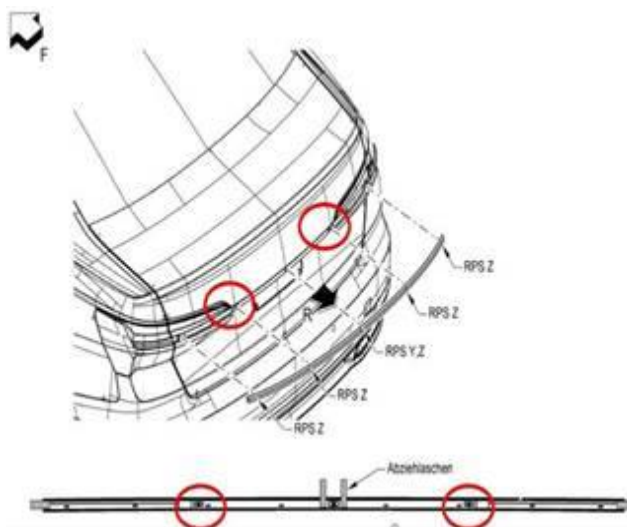
6. Additionally, sealer flaws or incorrect sealing of the rear lid trim can be found in the area where the rear lid exterior trim is mounted. Replace the rear lid trim strip if it is found to be the cause of the sealing issue.

**Figure 8.** Rear lid trim mounting areas to check for water ingress.

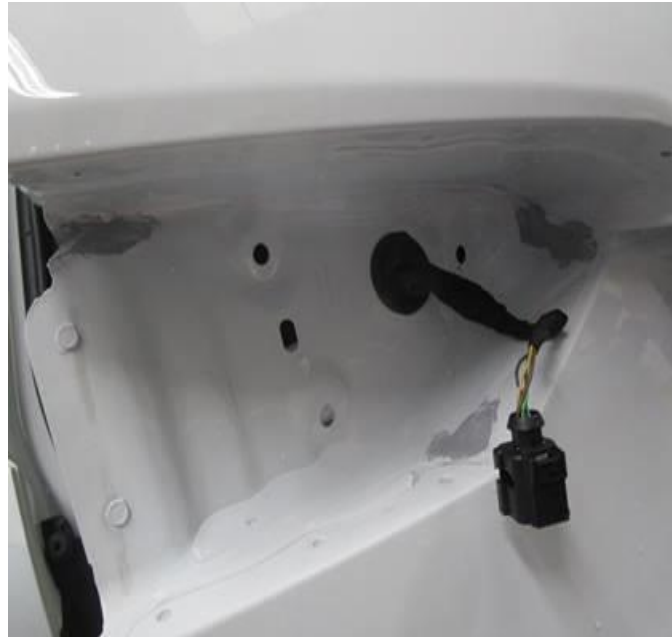
**Figure 9.** Concealed areas repaired with D 511 500 A2 1k adhesive sealant.
