### PIT5823 Possible Crank No Start or Extended Crank with DTC P12A6

Brand:	Model:	Model Years:	VIN:		Engine:	Transmissions:
			from	to		
Chevrolet	Equinox	2018 - 2021	All	All	All	All
GMC	Terrain	2018 - 2021	All	All	All	All

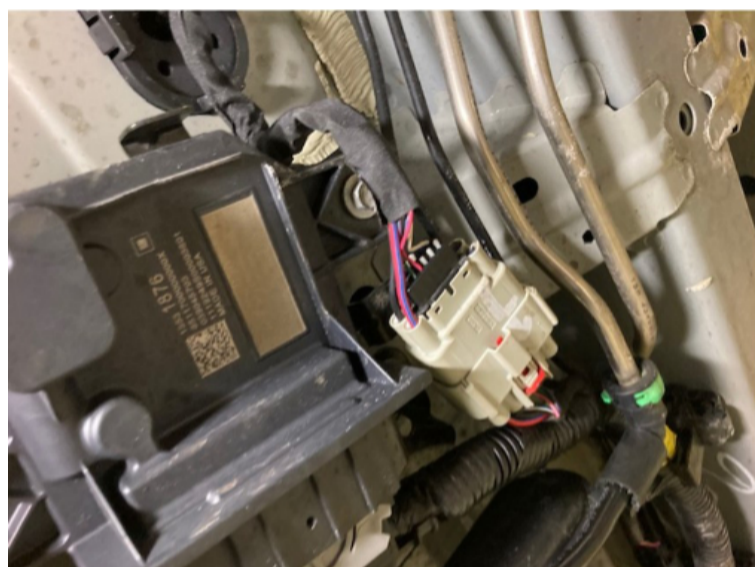
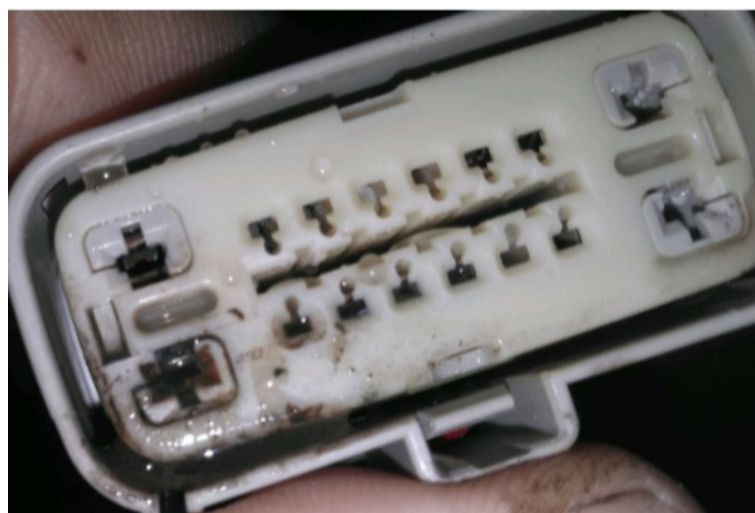
Example of corrosion which can cause a poor connection resulting in no-start. The water intrusion can also short terminals together, which can keep the fuel pump running after key off, draining the battery.

If there are issues, make repairs by replacing the connector with terminated leads on the body harness side, or by replacing the fuel tank harness, or both repairs if both sides show water intrusion, corrosion and/or damage.

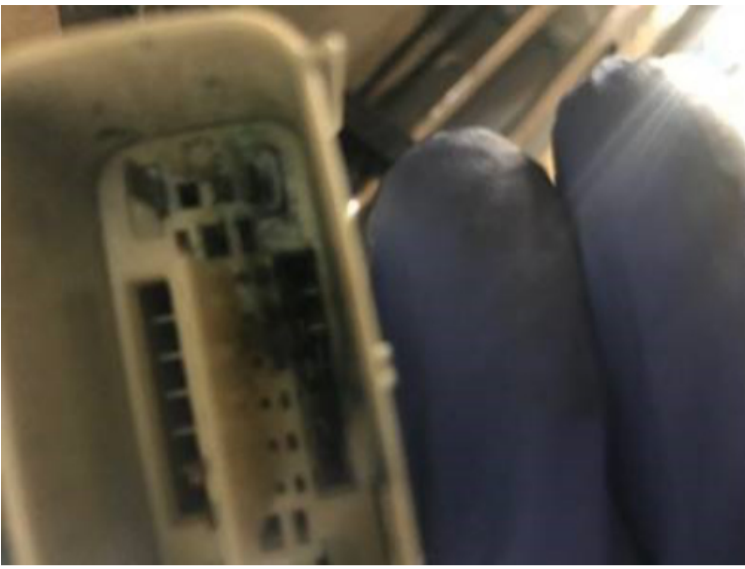
**Example of damaged connector at plugged cavity, which may displace the cavity plug, allowing water to enter.**

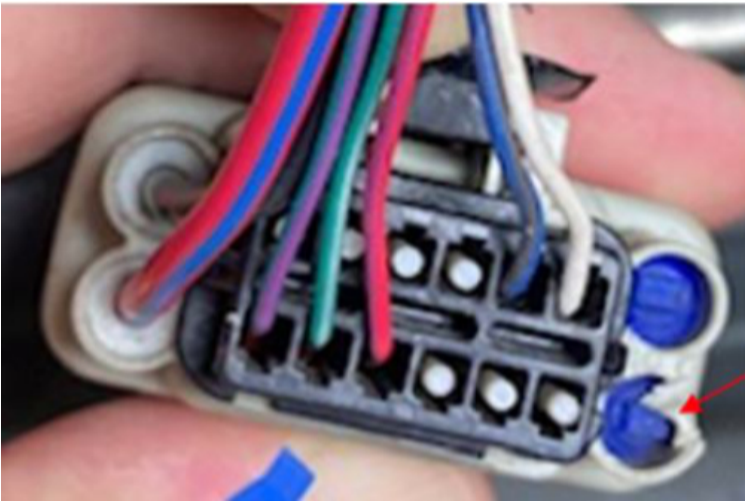
**Example of missing cavity plug**

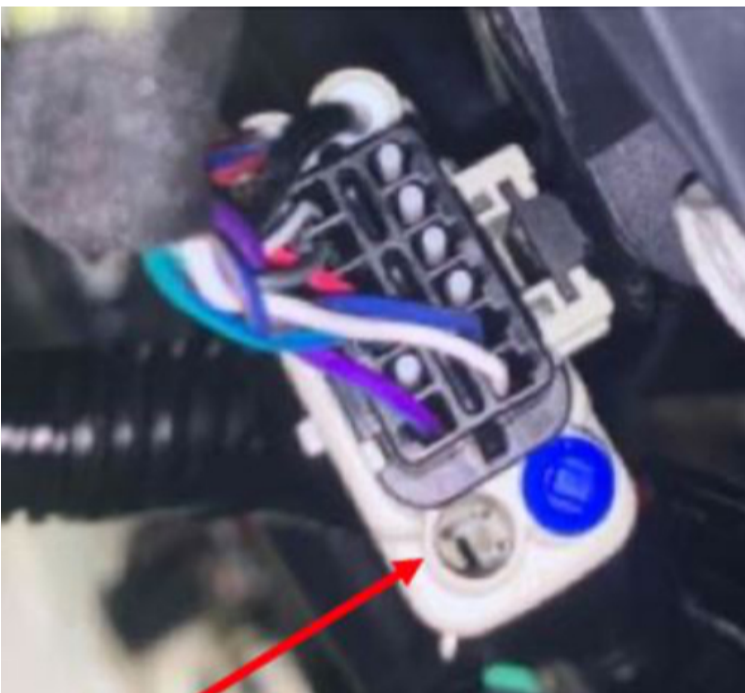
**Cavity plugs should be trimmed to prevent damage to the wire insulation.**
