Bulletin No.: PIP5745A
Published date: 03/23/2021

PIP5745A MIL illuminated with DTC P026A

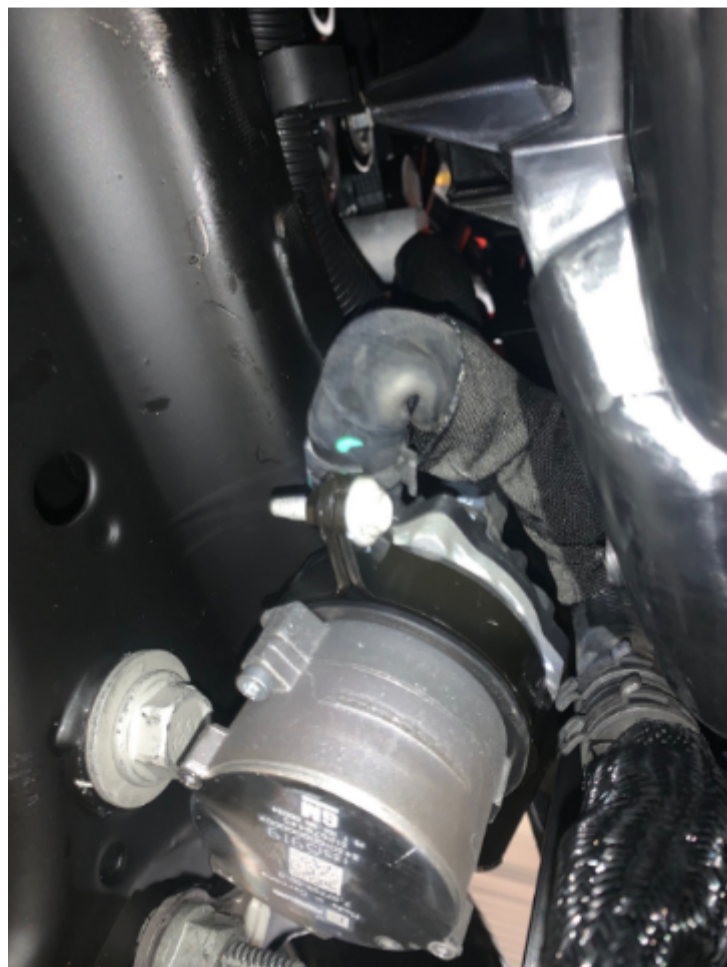
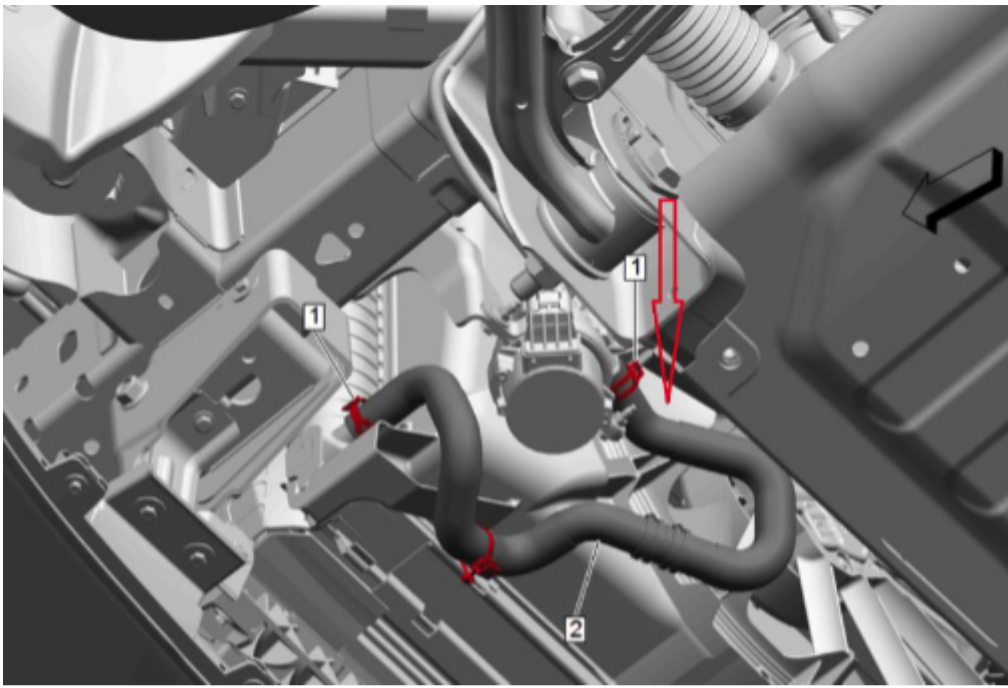
Involved Region or Country:	North America
Condition:	A vehicle may arrive at the dealer with the MIL illuminated and DTC P026A set.
Cause:	This may be due to a kinked hose at or near the low temperature auxiliary coolant pump.

If this condition is encountered, loosen the hose clamp and rotate the hose to allow for proper coolant flow.
