# Preliminary Information

## PIT5818 Poor Heater Performance On Drivers Side

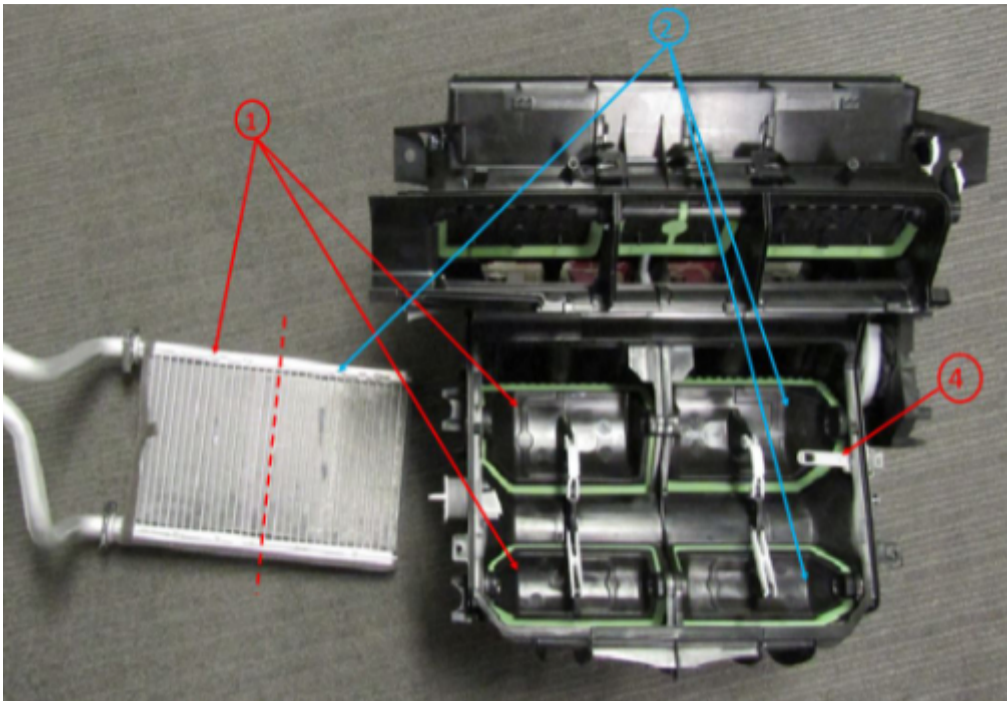
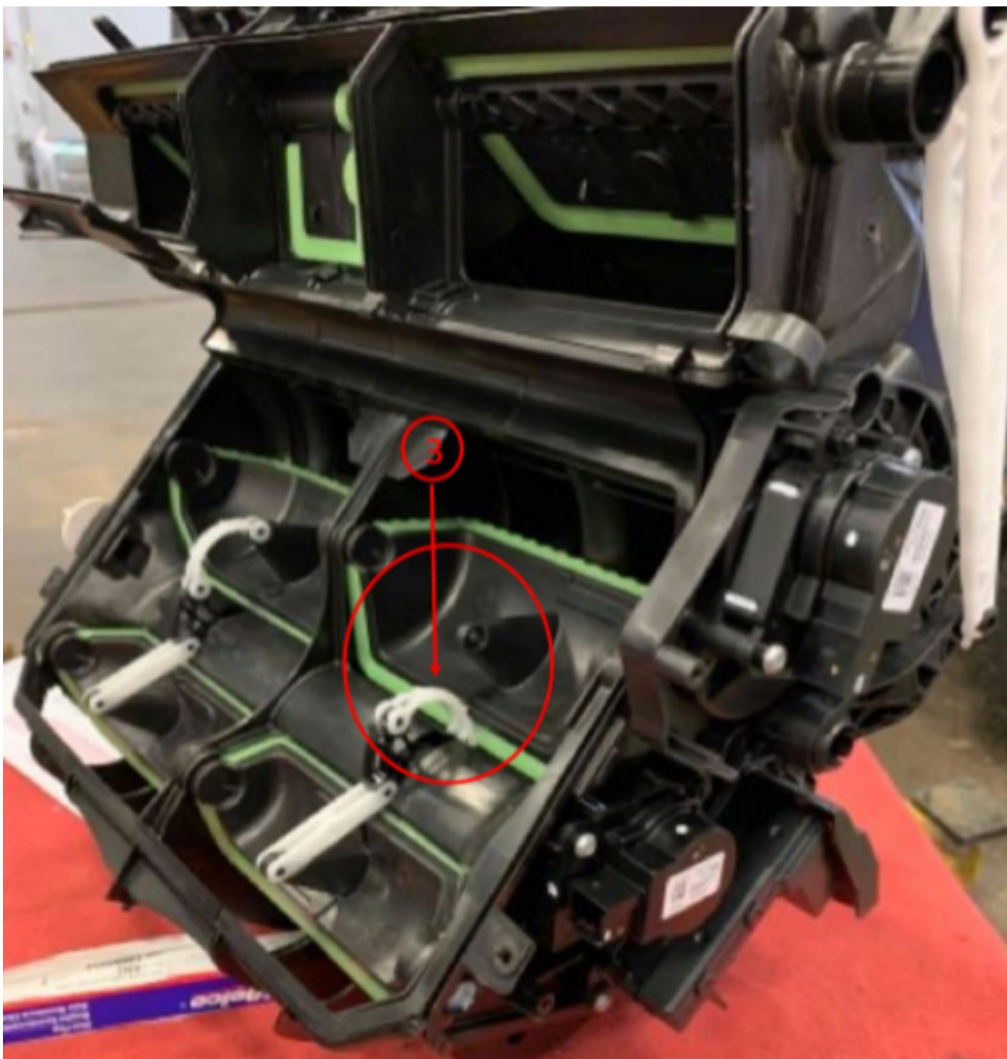
Involved Region or Country	North America
Condition	Some customers may comment on lower heater performance from the driver side HVAC vents when compared to the passenger side. In some cases, the driver side center dash vent will have the lowest temperature.
Cause	<p>The cause of this condition could be one of the following:</p> <p>Cause 1: The heater core may have become plugged. When the heater core begins to plug, it affects the driver side center vent first.</p> <p>Cause 2: Both single and dual zone HVAC cases utilize two temperature doors per side (a total of four doors), shown below. In the photo below, call-out 1 shows the passenger side temperature doors and heater core. Call-out 2 show the driver side temperature doors and heater core. Call-out 4 shows the evaporator air temperature sensor location in relation to the driver side temperature door which will be helpful later in this document. Inside the HVAC case, there are four white links which connect each of the four temperature doors. In some cases, one of these white links can become disconnected inside the HVAC case, as shown below (3).</p>
