Bulletin No.: PIP5712B Published date: 03/26/2021

PIP5712B Diagnostic Tip - Servicing Crankshaft Balancer and Cam Drive System Components

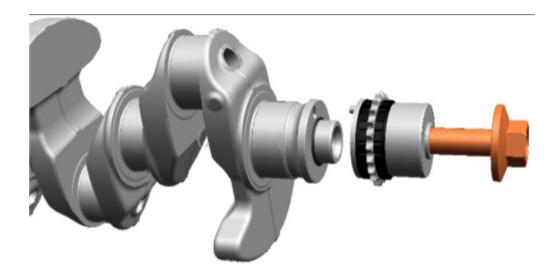
Involved Region or Country	North America
	Potential engine damage while servicing the Crankshaft Balancer and/or cam drive system related components
K alise	Crankshaft sprocket may disengage from crankshaft while servicing the crankshaft balancer and/or cam drive system related components

As shown below, the crankshaft sprocket is separate from the crankshaft and held in proper position by the crankshaft balancer and Bolt.

Caution: Do not rotate the crankshaft on these engines with the crankshaft balancer removed. The crankshaft balancer and bolt must be reinstalled to avoid damage to the crankshaft sprocket, crankshaft and valvetrain.
