Preliminary Information

PIP5212C Concern Of An Engine Thermostat Tick Noise And/Or Running Hot

A vehicle may have a concern of the engine running hot and/or has a tick noise from the thermostat.

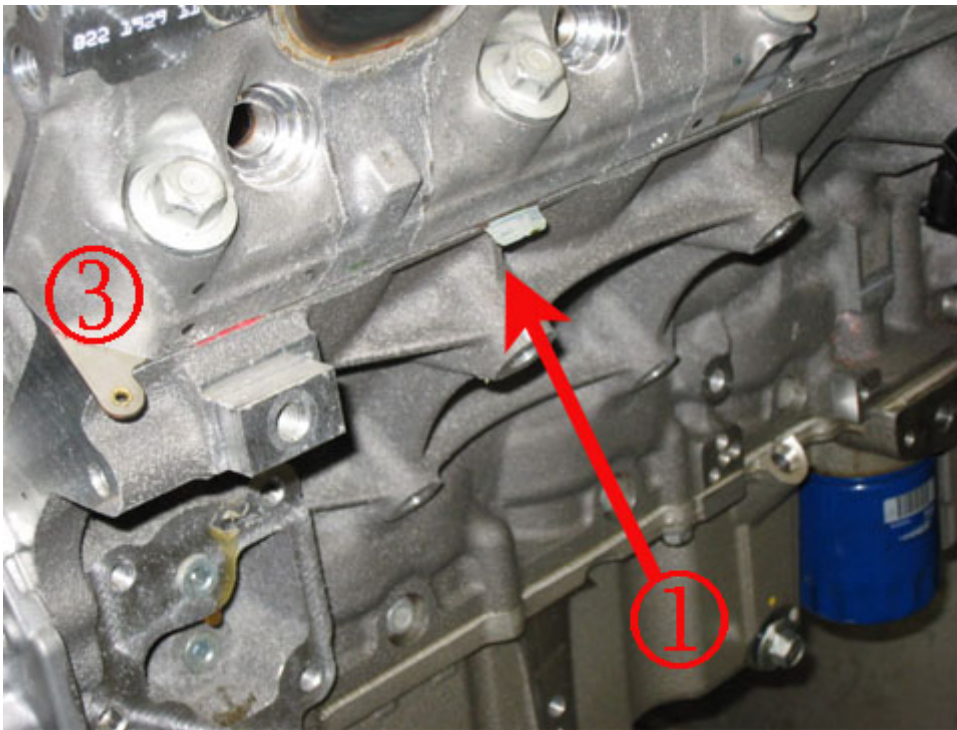
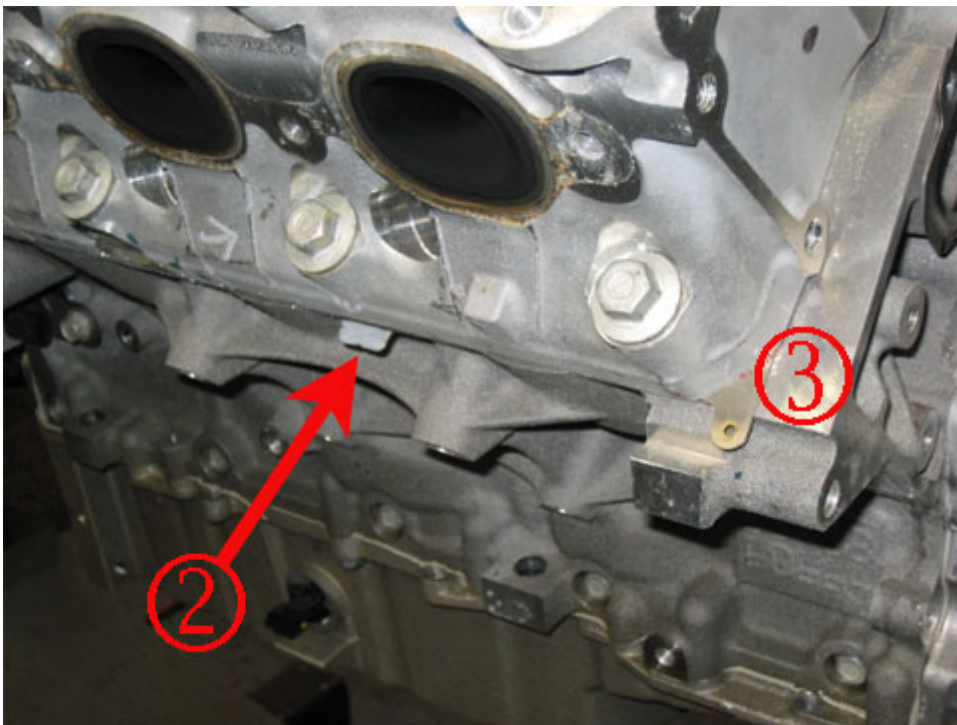
Per the attached pictures, the head gasket locating tabs for both of the engine cylinder banks should be toward the front of the engine.

1. Bank 1 tab near cylinder 3
2. Bank 2 tab near cylinder 4
3. Is the front of the engine

If the head gasket locating tabs are found to be closer to cylinders 5 or 6, this indicates the head gaskets were installed incorrectly restricting the engine coolant flow.

Replace the head gasket to repair for this concern.
