Preliminary Information

PIP5798 Vibration or Rough idle while in Drive or Park

Brand:	Model:	Model Years:	VIN:		Engine:	Transmissions:
			from	to		
Chevrolet	Silverado 1500	2019 - 2021	All	All	5.3L L82, L84 6.2L L87	All
GMC	Siarra1500	2019 - 2021	All	All	5.3L L82, L84 6.2L L87	All

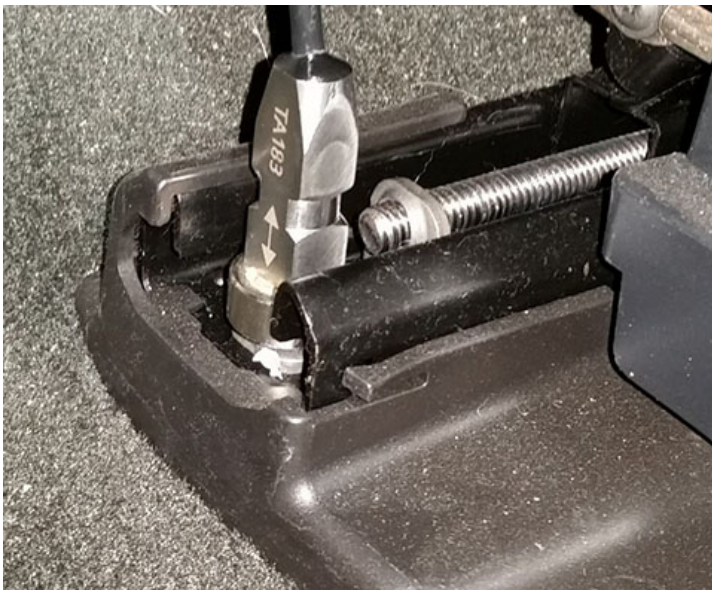
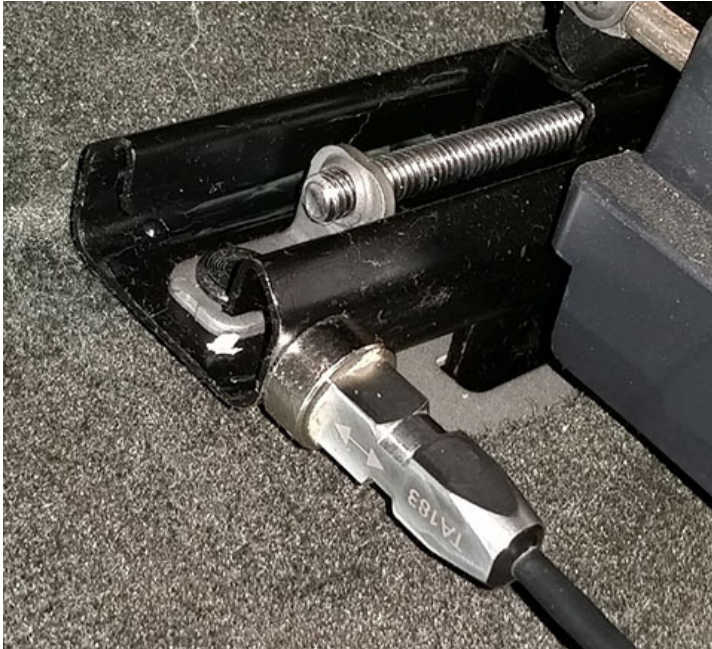
(TA183 single axis pico sensor shown / TA143 is tri-axis sensor)

5. Perform PICO analysis at the driver's seat track, refer to the Service Procedure section below. Record and save your file as this will be requested by TAC.

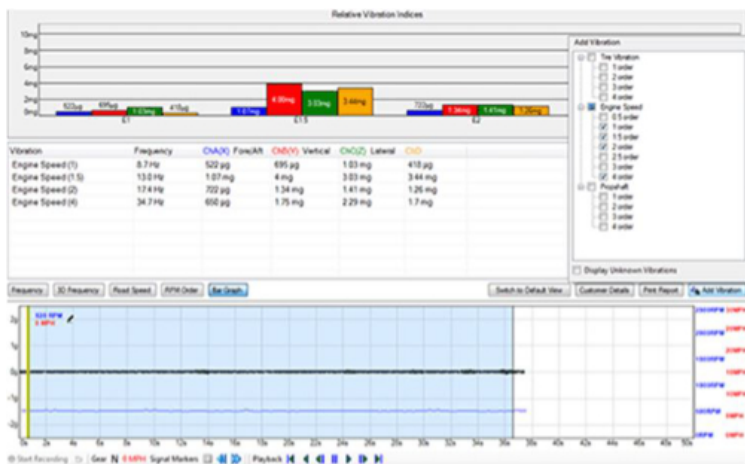
Add E1.5 to the displayed data and turn Off T and P related data (under Add Vibration in Pico) since issue occurs with vehicle stationary.

Note: Amplitude (mg) readings from a single-axis pico sensor will be approximately 10% lower than with a tri-axis sensor. For example, a reading of 4 mg using a tri-axis sensor, would likely measure as about 3.6 mg on a single-axis sensor.
