# Paint Stains Under Rapgard

**Service Category** Vehicle Exterior

**Section** Paint/Coatings

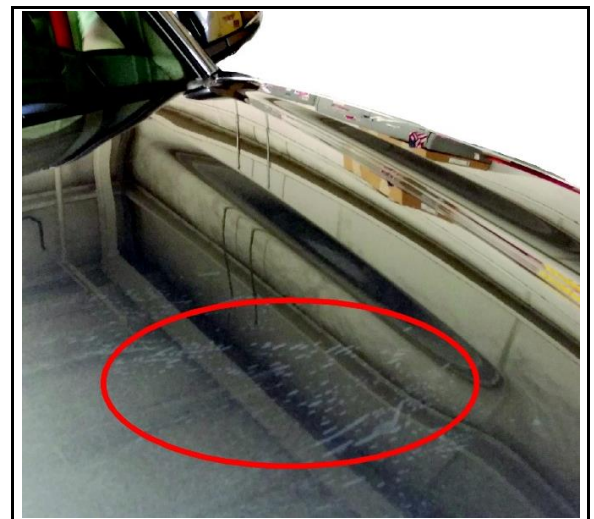
Figure 1.

Some 2010 – 2021 model year Toyota vehicles may exhibit paint stains after the removal of Rapgard™. The paint stains may appear to be under the clear coat but are usually under wrinkles in the Rapgard™. The wrinkles may trap water and cause the paint to stain from the trapped moisture, especially on horizontal surfaces such as the hood, roof, and trunk. Follow the Repair Procedure in this bulletin to address this condition.

1. Confirm the condition exists.  
 AFTER Rappgard™ removal, does the vehicle exhibit paint stains as shown?
  - **YES** — Continue to step 2.
  - **NO** — This bulletin does NOT apply. Continue diagnosis using the applicable Repair Manual.

It is NOT necessary to repaint the stained area.

2. Using aluminum foil or a damp cloth, cover ANY plastic and/or rubber parts located near the stain.

3. With an infrared lamp or heat gun, apply heat to the stain for 5 – 10 minutes at 158°F – 176°F (70°C – 80°C).

**Do NOT allow the surface to become hotter than 176°F (80°C). Measure the temperature with a thermometer.**

4. Wait AT LEAST 5 minutes AFTER heat application, then examine the area and determine if the stain has been removed.
