# MIL ON DTC P125D71 - Fuel Flow Control Valve Stuck

**Service Category** Engine/Hybrid System

YEAR(S)	MODEL(S)	ADDITIONAL INFORMATION
2015 - 2017	NX200T	
2018 - 2020	NX300

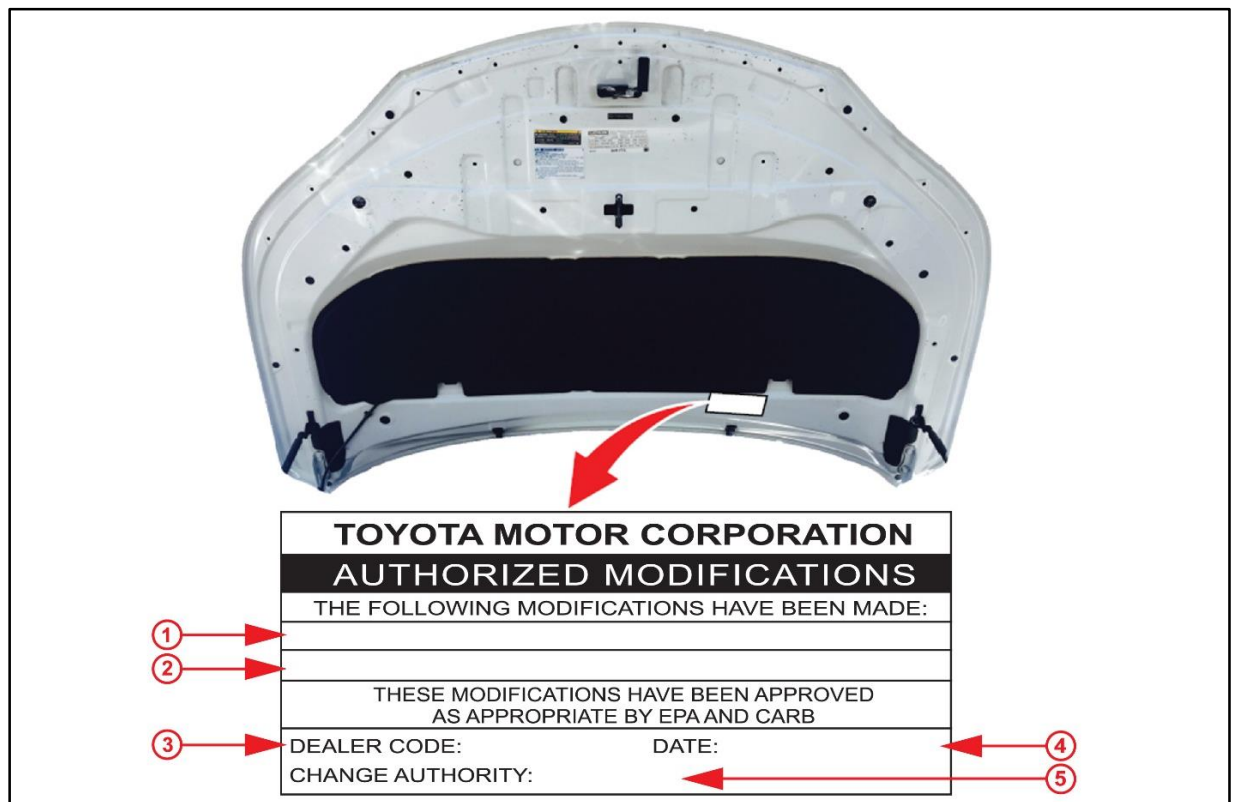
**Figure 1. Location of Authorized Modifications Label on 2015 – 2017 NX 200t and 2018 – 2020 NX 300**

3. Use Techstream to confirm if the ECM (PCM) calibration has been updated and check for the Authorized Modifications Label affixed to the vehicle in the location shown below. Is the calibration ID listed in Techstream and on the label the latest ECM (PCM) calibration?
  - **YES** — This bulletin does NOT apply. Continue diagnosis using the applicable Repair Manual.
  - **NO** — Continue to step 4.

5. Prepare and install the Authorized Modifications Label.
  - A. Using a permanent marker, enter the following information on the label:
    - ECM (PCM) part number [Refer to the Parts Information section for the NEW PART NUMBER]
    - Calibration ID(s) [Refer to the Calibration Information section for the NEW CALIBRATION ID]
    - Dealer Code
    - Repair Date
    - Change Authority [This bulletin number]
  - B. Install the Authorized Modifications Label onto the vehicle at the location shown in Figure 1. The Authorized Modifications Label is available through the MDC, P/N 00451-00001-LBL.

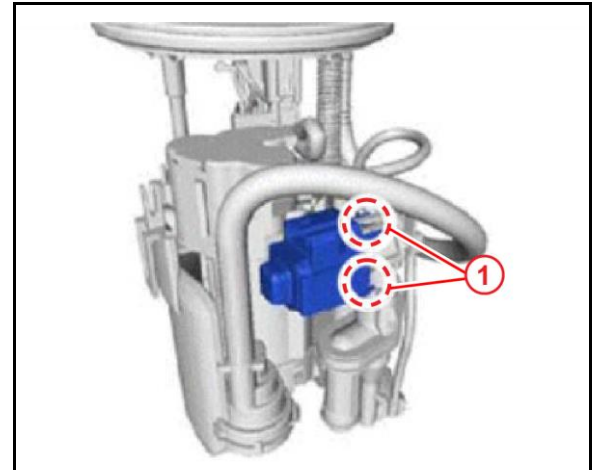
**Figure 2.**

<b>1</b>	<b>Claw Location</b>
----------	----------------------

8. Remove the pressure discharge valve from the fuel suction plate sub-assembly.
  - A. Disconnect the connector from the pressure discharge valve assembly.
  - B. Detach the two claws and pressure discharge valve assembly from the fuel suction tube assembly with pump.

9. Install the NEW pressure discharge valve and attach the two claws and pressure discharge valve assembly to the fuel suction tube assembly with pump.
