Depleted 12V Vehicle Battery

Service Category Power Source/Network

Section Battery/Charging

YEAR(S)	MODEL(S)	ADDITIONAL INFORMATION
2021	Sienna HV

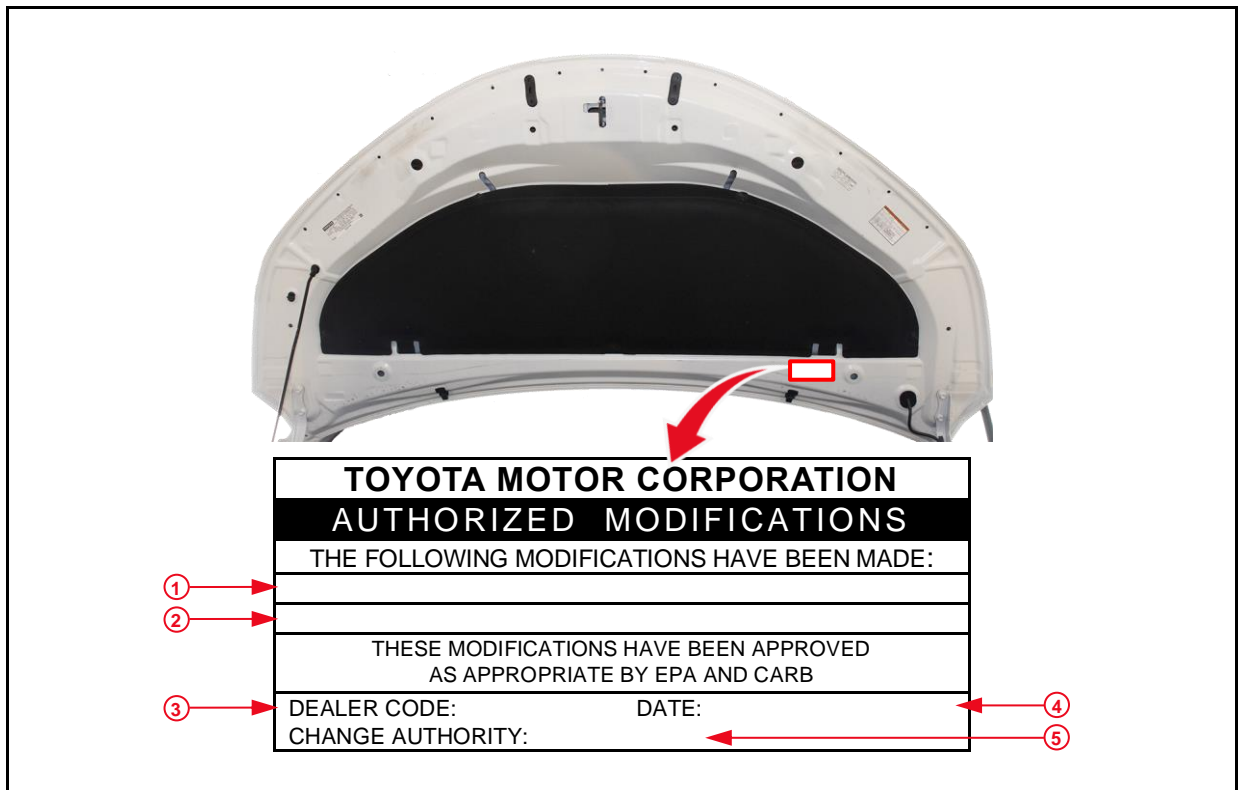
Figure 1. Location of Authorized Modifications Label on 2021 Sienna HV

- Use Techstream to confirm if the HV ECU calibration has been updated and check for the Authorized Modifications Label affixed to the vehicle in the location shown below.

Is the calibration ID listed in Techstream and on the label the latest HV ECU calibration?

- Prepare and install the Authorized Modifications Label.
 - Using a permanent marker, enter the following information on the label:
 - HV ECU part number [Refer to the **Parts Information** section for the **NEW PART NUMBER**]
 - Calibration ID(s) [Refer to the **Calibration Information** section for the **NEW CALIBRATION ID**]
 - Dealer Code
 - Repair Date
 - Change Authority [**This bulletin number**]
 - Install the Authorized Modifications Label onto the vehicle at the location shown in Figure 1. The Authorized Modifications Label is available through the MDC, P/N 00451-00001-LBL.
- Test-drive the vehicle to confirm proper operation.
