Subject <b>Scrape Noise From Front While Turning</b>		Market <b>USA</b>
Service Category <b>Brake</b>	Section <b>Brake (front)</b>	
Applicability <b>2021 Sienna HV</b>

2021	Sienna HV
------	-----------

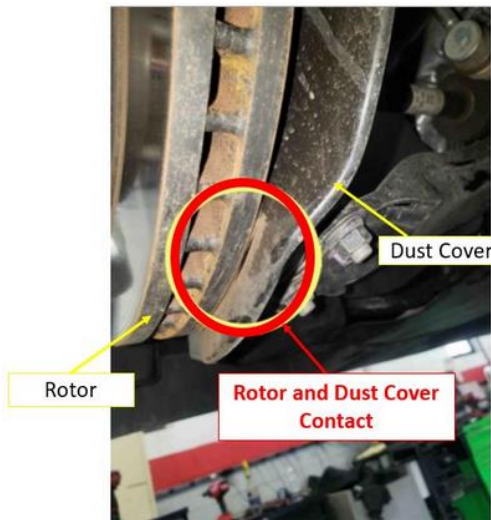
Some 2021 model year Sienna HV vehicles may exhibit a scraping noise from the front when turning.

- 1) Mileage is under 5,000 miles
- 2) Vehicle has not had previous front brake repairs performed
- 3) Vehicle has not had prior adjustments to the dust cover
- 4) Confirm there is Rotor and Dust Cover contact. See photo.

If the vehicle meets the criteria above, please create a TAS case and include photos of the contact between the dust cover and rotor. **DO NOT make any adjustments to dust cover.** TAS will provide further instruction.
