# Technical Service Bulletin

## 91 MIB2+: Software Update Instructions

91 21 90 2056558/2 April 13, 2021. Supersedes Technical Service Bulletin Group 91 number 19-01 dated October 16, 2019 for reasons listed below.

Model(s)	Year	VIN Range	Vehicle-Specific Equipment
A6, A7, A8, S8, Q7, SQ7, Q8, Q3, and Audi e-tron quattro	2019 - 2020	All	MIB2+
A6 allroad, S6, RS 6, S7, RS 7, SQ8, RS Q8, and Audi e-tron Sportback	2020	All	MIB2+

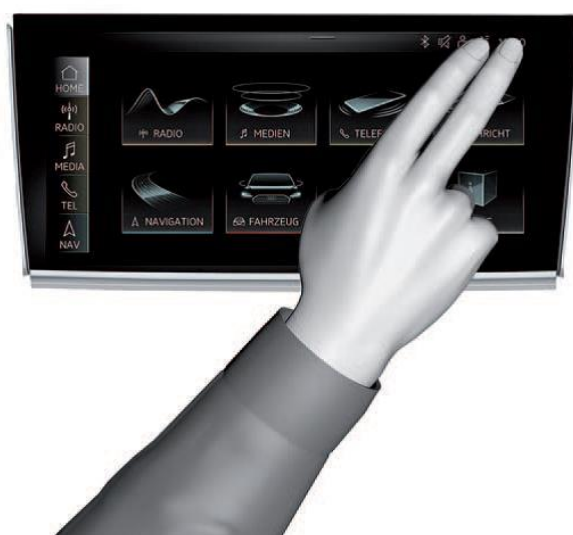
1. Enter the red engineering menu by touching the screen with two fingers in the top right corner (Figure 1).

**Figure 1.** Gesture to enter the red engineering menu.

2.
  - Use the volume control to navigate the red engineering menu (left and right for scrolling, push to select).
  - Select "Update" and the source of the update medium, usually SD slot 1.
  - All control units to be updated are shown, scroll all the way down and start the update.
3. After the manual successful update perform the SVM code again so that the ODIS tester can make the necessary configuration and report the new vehicle configuration to the SVM server.
