Lower Rear Engine Cover Cracked

Year	Model	Trim Level
2022	MDX	ALL

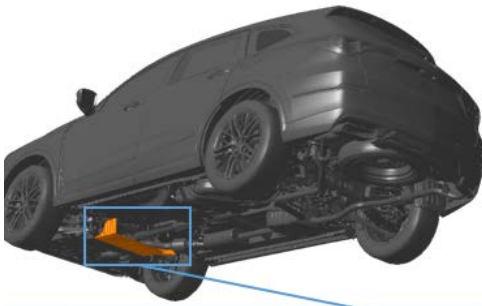
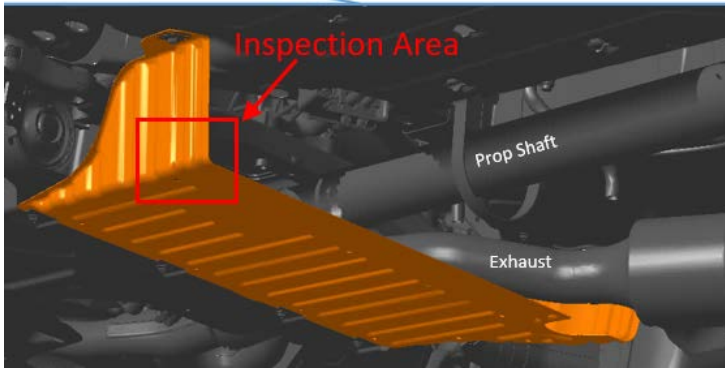
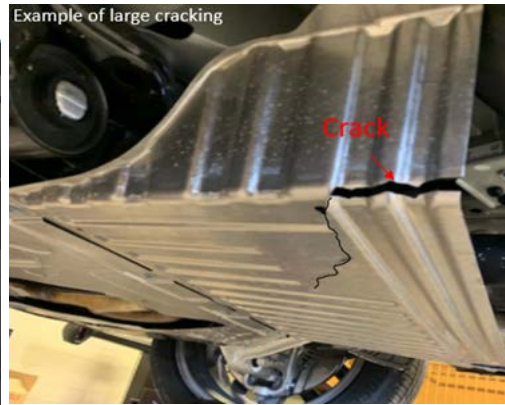
We are receiving reports that a few dealers have found the lower rear engine cover cracked when doing the PDI. Inspect this cover as soon as the vehicles arrive at your dealer and any vehicles currently in your new car inventory. If you find a cracked cover, order, and replace the cover with (P/N 74114-TYA-A00) and promptly file a warranty claim using Labor Operation Number: 8131M1.
