Work Instructions

Subject: Battery Cable Access (BCA) 29A Cable Inspection

Models Affected: All New Cascadia Vehicles

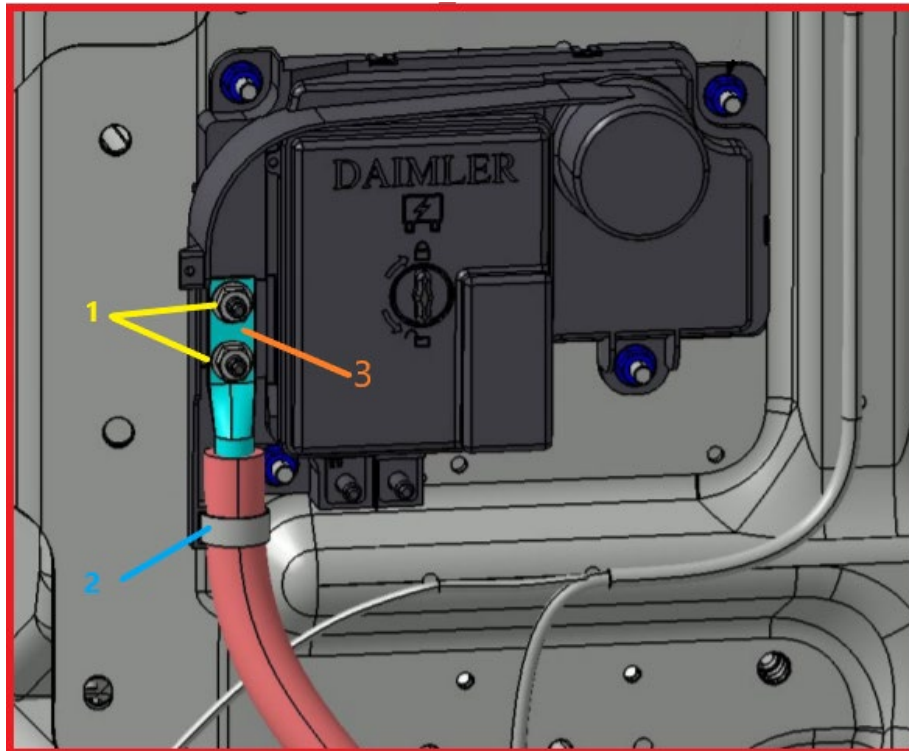
Fig. 1, Battery Cable Access Location

The BCA is located on the passenger side of the engine wall, facing forward. See **Fig. 1**.

1. Studs Securing Main Positive 29A cable to the BCA.
2. Zip Tie Securing Cable to BCA
3. Cable End and BCA Plate Connection

2. Disconnect the batteries.
3. Open the hood.
4. Locate the two studs that secure the main positive 29A cable to the BCA. See callout 1 in **Fig. 1**.
