TITLE:
Squeaking noise under front seats cushions

REF NO: US35817.2.0 en-US	ISSUING DEPARTMENT: Technical Service	CAR MARKET: United States and Canada	
PARTNER: 3 US 7510 Volvo Car USA		ISSUE DATE: 2020-03-03	STATUS DATE: 2021-03-08
FUNC GROUP: 8526	FUNC DESC: Adjustment device, assembly parts	Page 1 of 3

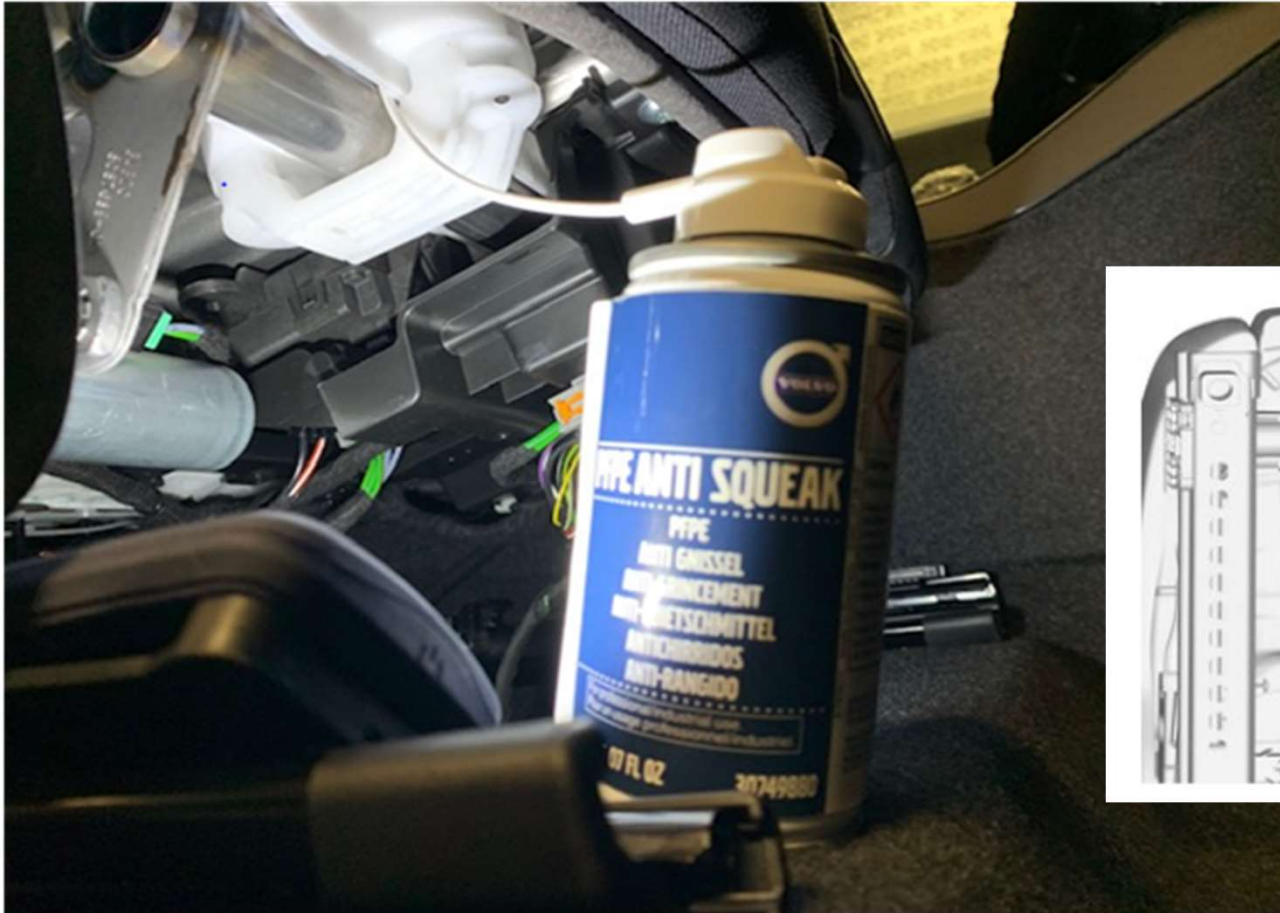
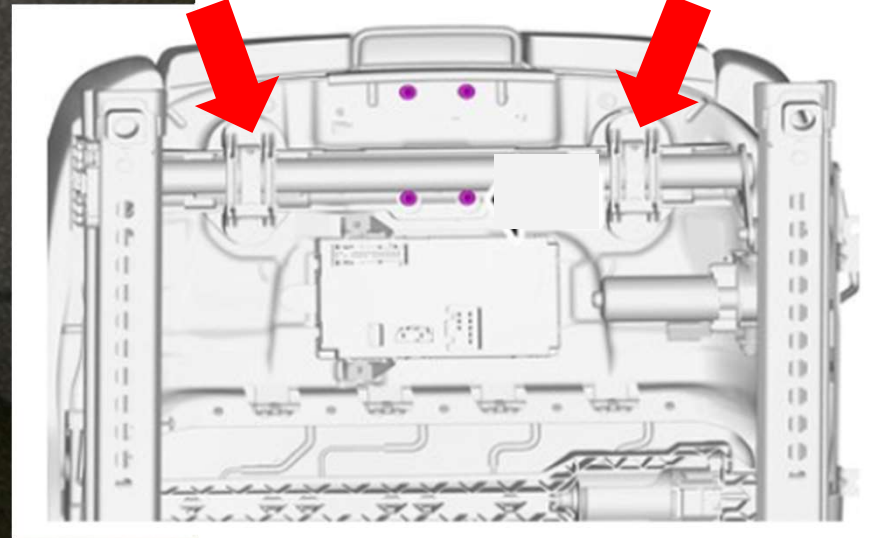
TJ 35817

If squeaking noise can be heard from the underside of a front seat cushion, see Service

Apply PTFE-spray as shown on picture “TJ 35817.pdf” (2 plastic holders on each front seat).

Raise the seat to the highest and apply from front.

Use PFTE-spray p/n 30749880.
