2021FA02  
March 05, 2021  
Product Code(s): 66  
Page 1 of 13

SUBJECT: Volvo 9700 TCM Recalibration and C1 Drive Hub Certification

MODELS AFFECTED: B 500™

**PREVOST SAFETY RECALL SR21-81 ALLISON TRANSMISSION  
C1 HUB FAILURE**

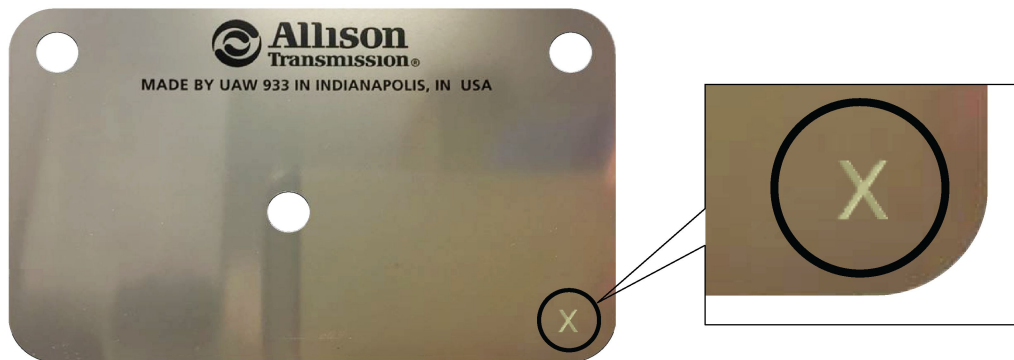
**Figure 1. Identification Mark**

4. When the vehicle arrives, confirm the transmission serial number is in range per [Table 1](#) and included in [Table 5](#).
5. Verify the transmission nameplate does not have an “X” Identification Mark indicating this Field Action service work has already been performed. Refer to [Figure 1](#).

18. After all work is complete, place an identifying mark on the transmission nameplate as shown in [Figure 1](#) to indicate work has been completed.
