STAR ONLINE PUBLICATION

Case Number: S2108000062

Symptom/Vehicle Issue: Rumbling, Rough Engine Vibration 1600 to 1800, CEL (Check Engine Lamp) On, Cylinder Misfire DTC's

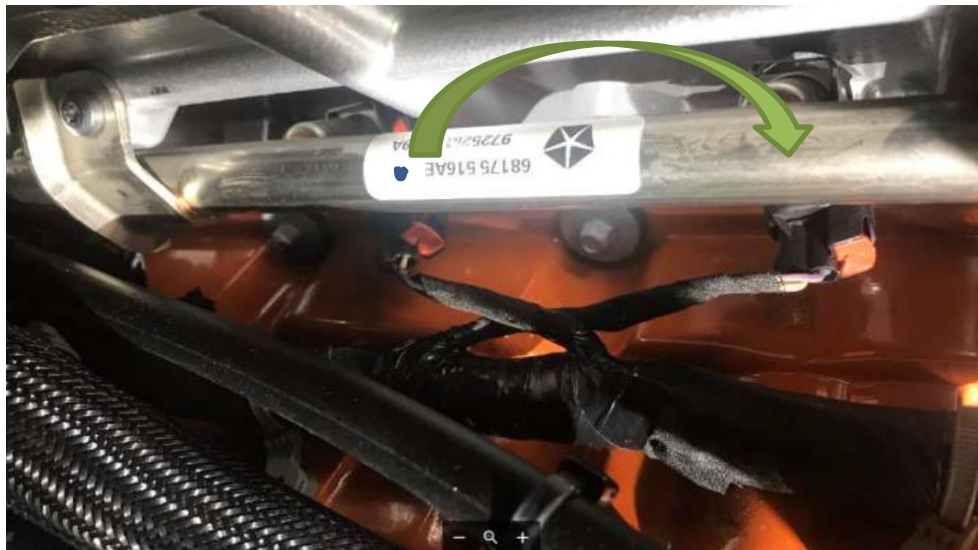
6.2L – DT Ram

Repair Procedure: The below example is consistent with the DTC's in this case, where the number 4 and 6 harness connections were improperly connected, (crossed) to the wrong injector position. Different DTC's will set if other injectors are involved. This condition may not set immediately but requires some driving and PCM fuel adaptive changing to trigger the event.
