STAR ONLINE PUBLICATION

Case Number: S2123000017

Symptom/Vehicle Issue: Water Leak From Front Seat Grab Handle And Or A Pillar

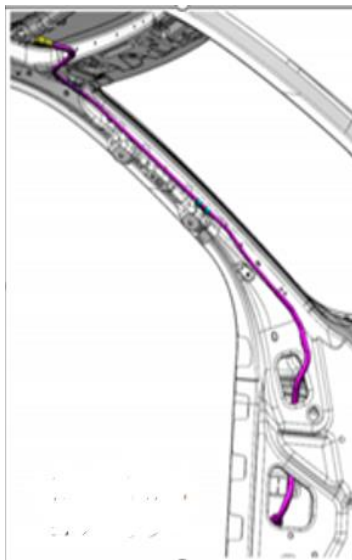
Fig 1

Discussion: Sunroof drain tubes are routed down the A Pillar (fig 1). Inspect the routing of the A Pillar drain tubes for possible kinking or blockage. If not found kinked, verify the tube is fully connected at the sunroof frame.
