## STAR ONLINE PUBLICATION

**Case Number:** S1924000008

**Symptom/Vehicle Issue:** Front Defrost Only Clears Part Of The Windshield

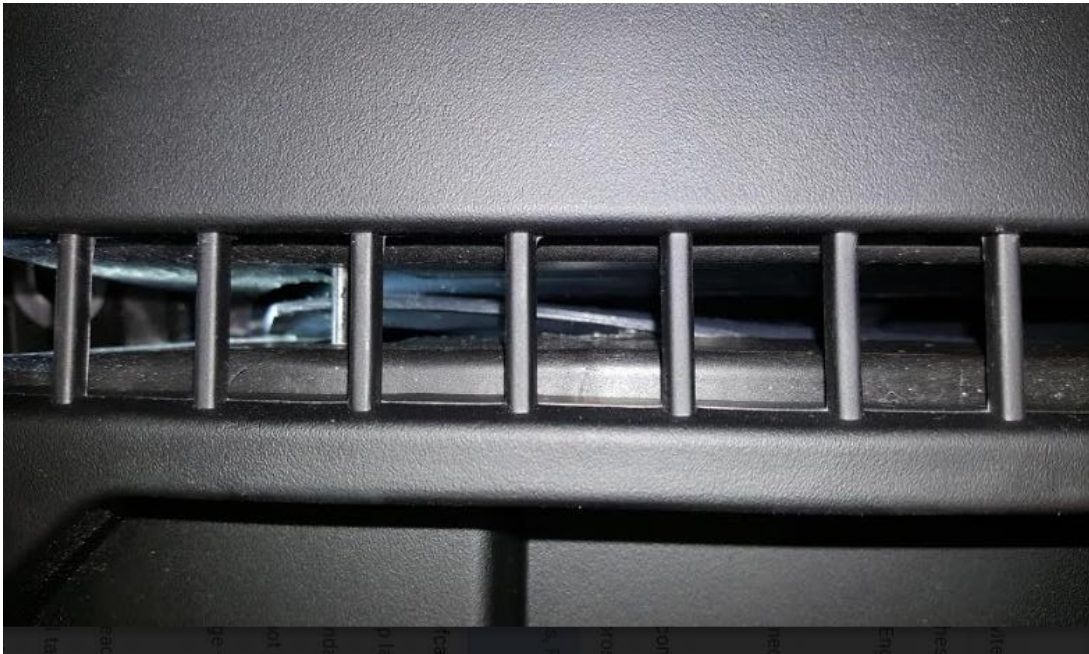
**Discussion:** Customer complaint is that the majority of the front defrost heat flow is centered in the middle or the middle and one side of the windshield. It has been discovered that the top cover pinched some of the defrost ducts and therefore restricting the flow on the outboards of the defrost ducts. Picture shown below.

**Repair Procedure:** If this condition is found it is necessary to remove the IP cover and ensure that the defrost ducts are routed into the correct position.

**Verification:** Reassemble the dash and test for air flow.
