## STAR ONLINE PUBLICATION

**Case Number:** S2008000190 – REV. B

**Symptom/Vehicle Issue:** User Is Unable To Create A New Profile In The R1H Radio Uconnect 5

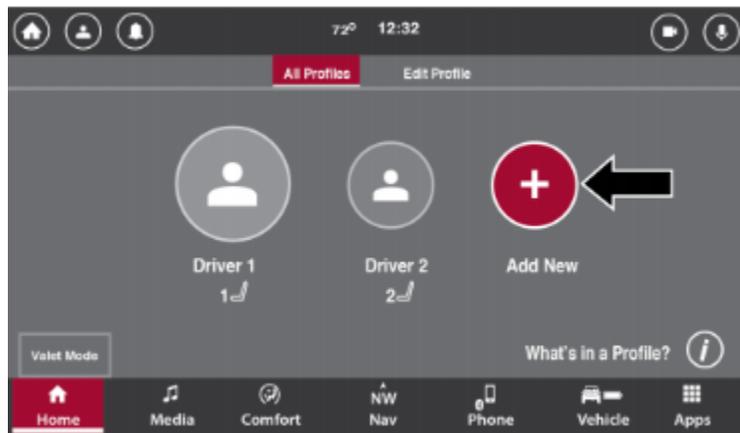
Fig 1 Add New Profile.

**Discussion:** User is unable to create a new profile in the R1H Radio. Soft keys are not visible on the radio to add a new profile. This feature is **Not** available on early built vehicles.

**Do Not Replace The Radio (ETM), TBM, or Display** for this concern. This feature is not available on early built vehicles. The feature will be activated by an over-the-air update tentatively in 2<sup>nd</sup> quarter 2021.
