STAR ONLINE PUBLICATION

Case Number: S2108000082

Symptom/Vehicle Issue: Interior Lighting Inoperative, Dome, Reading, Glove Box, Center Console, Vanity Lamp, Rambox Lighting

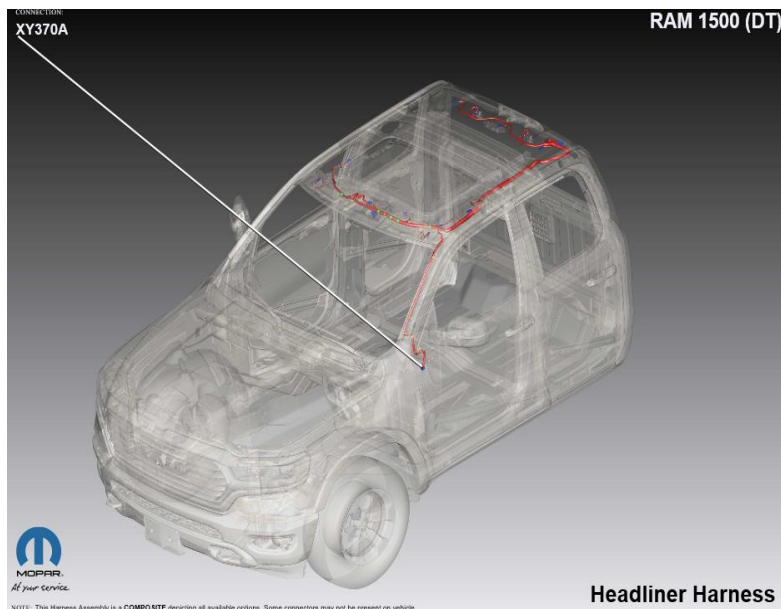
Fig 1

If vehicle is setting no communication with the overhead DTC U114F-00 review the D402 LIN BUS CBC 2 pin retention on both the headliner harness connector and IP harness connector Fig 1, 2.

Repair Procedure: Open the driver door and remove the IP end cap following the standard procedure in service library. Disconnect the black 21-way inline connector XY370A, inspect for spread, bent or pushed out terminals on any of the involved lighting circuits M11 COURTESY LAMPS DRIVER, M27 READING LAMPS DRIVER, M5 AMBIENT LIGHTING CONTROL, E12 PANEL LAMPS DRIVER clean and secure as needed no parts required.
