**NUMBER:** 08-046-21

UGQ Radio Enhancements

2019 (JL) Jeep Wrangler

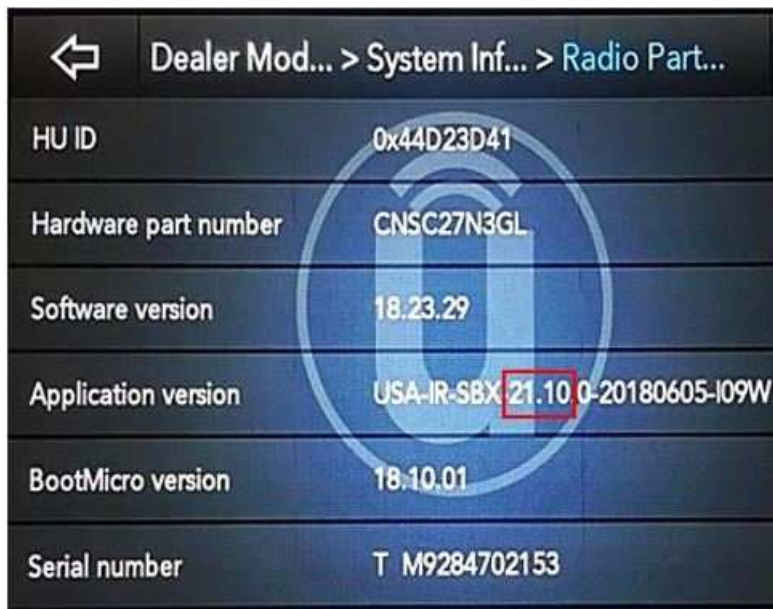
Fig. 1

Radio Software Level Screen

2. What is the radio software level (Application Version) at?
  - 39.2 or higher >>> The radio software is already up to date. Normal diagnostics should be performed.
  - At or above 28.3 and under 39.2 >>> The radio will only need one USB flash drive to update the radio. Create a USB flash drive with 39.2 software. Proceed to [Step 1](#) of the Repair Procedure.

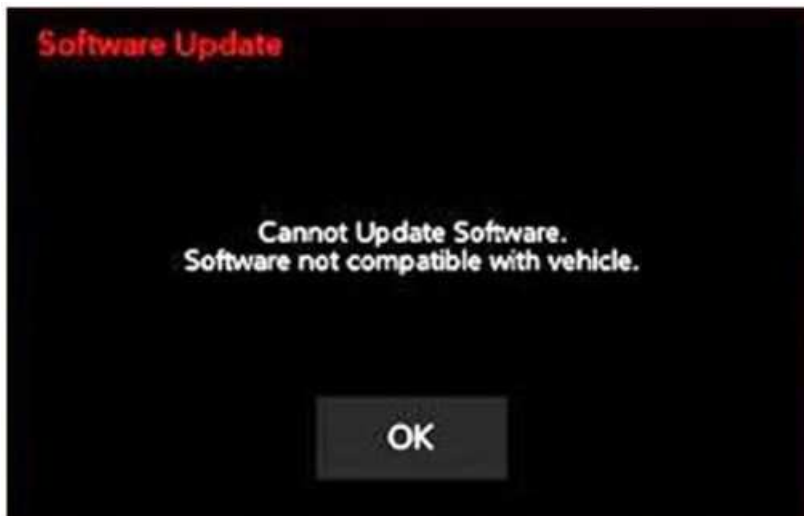
11. If the screen in (Fig. 5) is displayed, the USB flash drive was not set up correctly. Use a top name brand USB flash drive, like Kingston, create a new USB flash drive and start the update again.

Fig. 5  
Software Not Compatible Screen

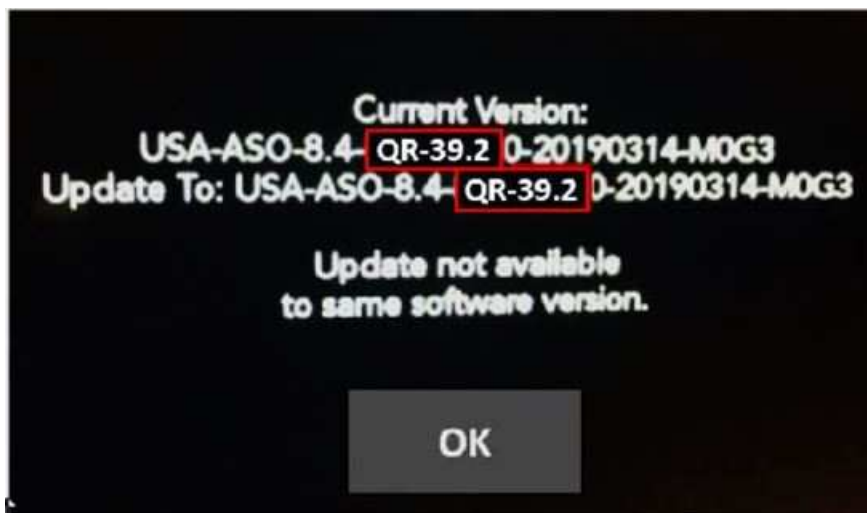
12. If the radio software is already up to date, the screen in (Fig. 6) will be displayed. Press "OK" and remove the USB flash drive.

Fig. 6  
Screen Displayed When Radio Software Level Is Up To Date

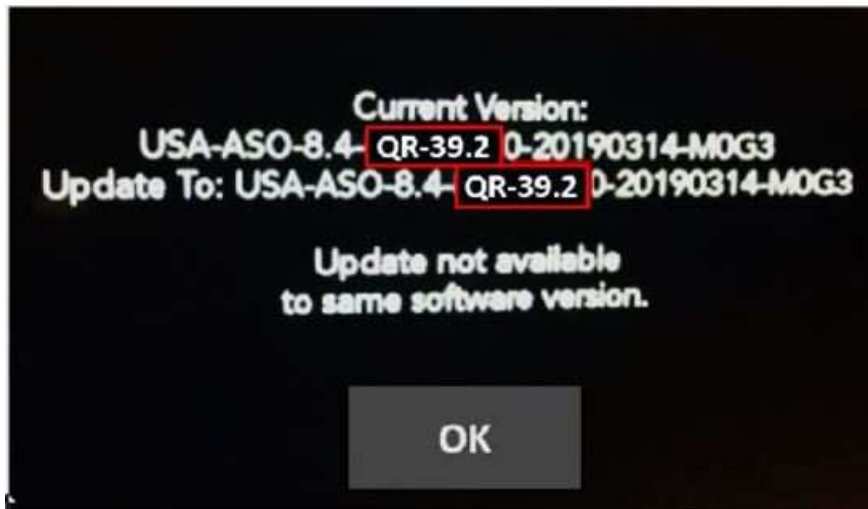
16. After the update has completed, the radio will shut down. With the USB flash drive still inserted in the USB port, cycle the ignition back to the run position. If the radio software was updated correctly the “Current Version:” and the “Update To:” software levels in (Fig. 10) will display the identical software level. Press “OK” and remove the USB flash drive.

Fig. 10  
Radio Software Has Been Updated Screen
