NUMBER: 09-003-21

GROUP: 09 - Engine

Transmission Oil Cooler Lines Not Fully Connected

2020 - 2021 (DT) RAM 1500 Pickup

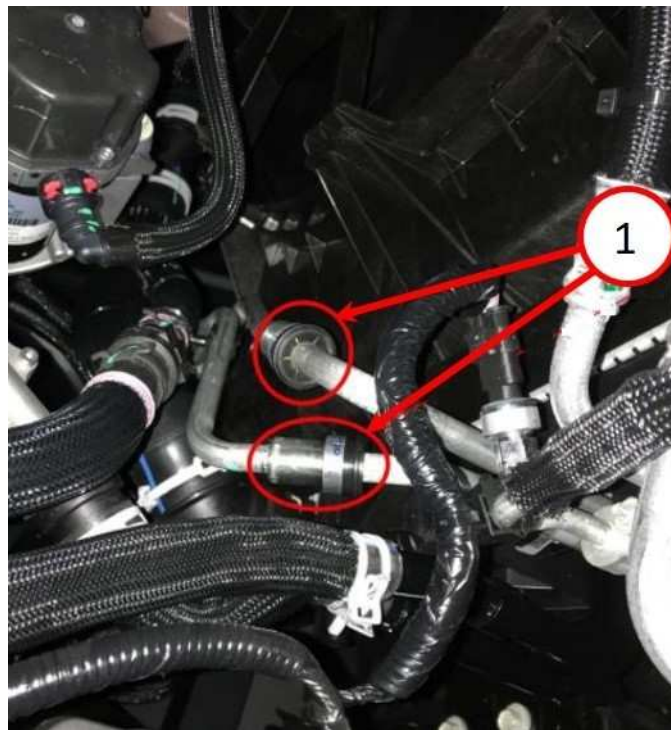
Fig. 1

1. Inspect the TOC lines by pulling on lines to see if they come loose and separate the connection. The black assurance caps (Fig. 1) need to be pulled back to inspect.

Transmission Oil Cooler Line (Shown Connected)
