Subject: N202325461 - Service Update  
Automated Driving Mapping Module Software Update

Models: 2021 Cadillac Escalade

# Service Update

## N202325461 Automated Driving Mapping Module Software Update

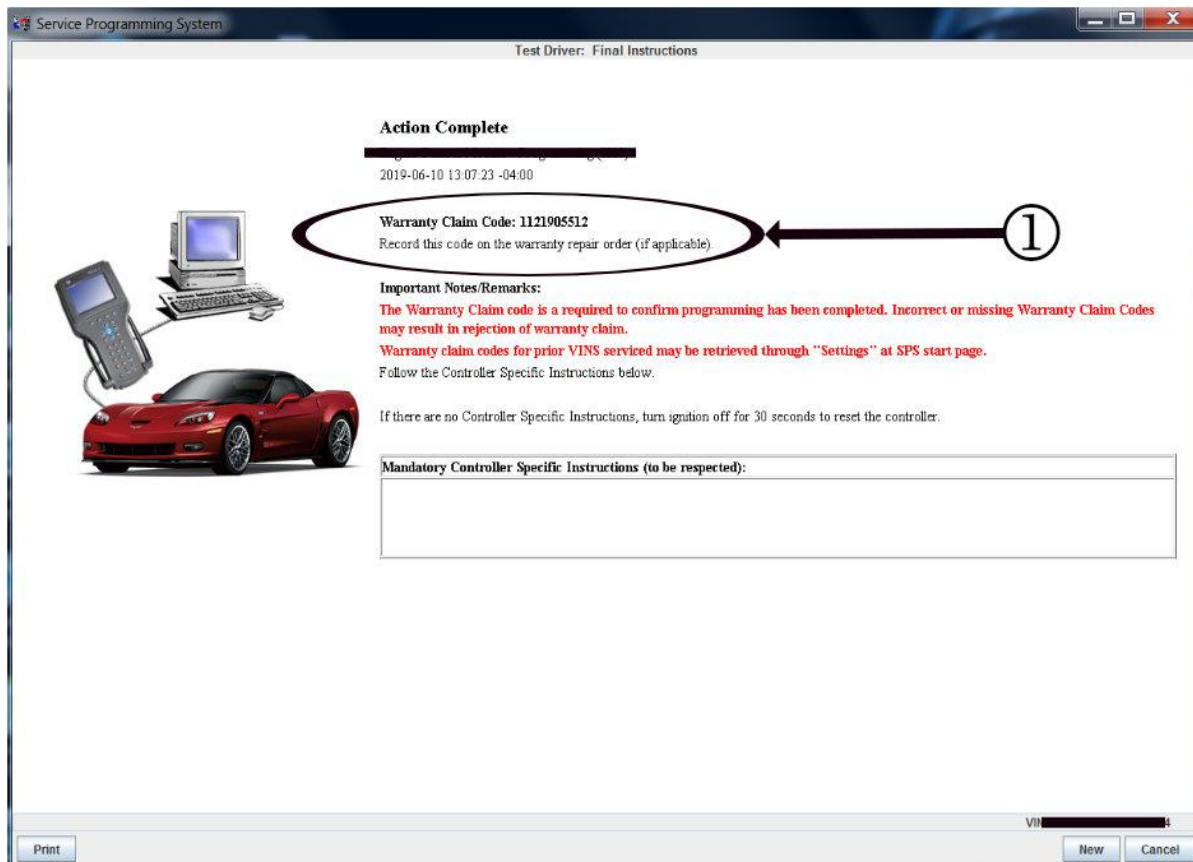
5431209

**Important:** To avoid warranty transaction rejections, you MUST record the warranty claim code provided on the Warranty Claim Code (WCC) screen shown above on the job card. Refer to callout 1 above for the location of the WCC on the screen.

2. Record SPS Warranty Claim Code on job card for warranty transaction submission.
