GLOBAL SAFETY FIELD INVESTIGATIONS
DCS5740
URGENT - DISTRIBUTE IMMEDIATELY

Subject: REVISION – N202325460-01 - Service Update
Radio Software Update
Revised the service procedure and the warranty information table.

Models: 2021 Cadillac Escalade and Escalade ESV

N202325460 Radio Software Update

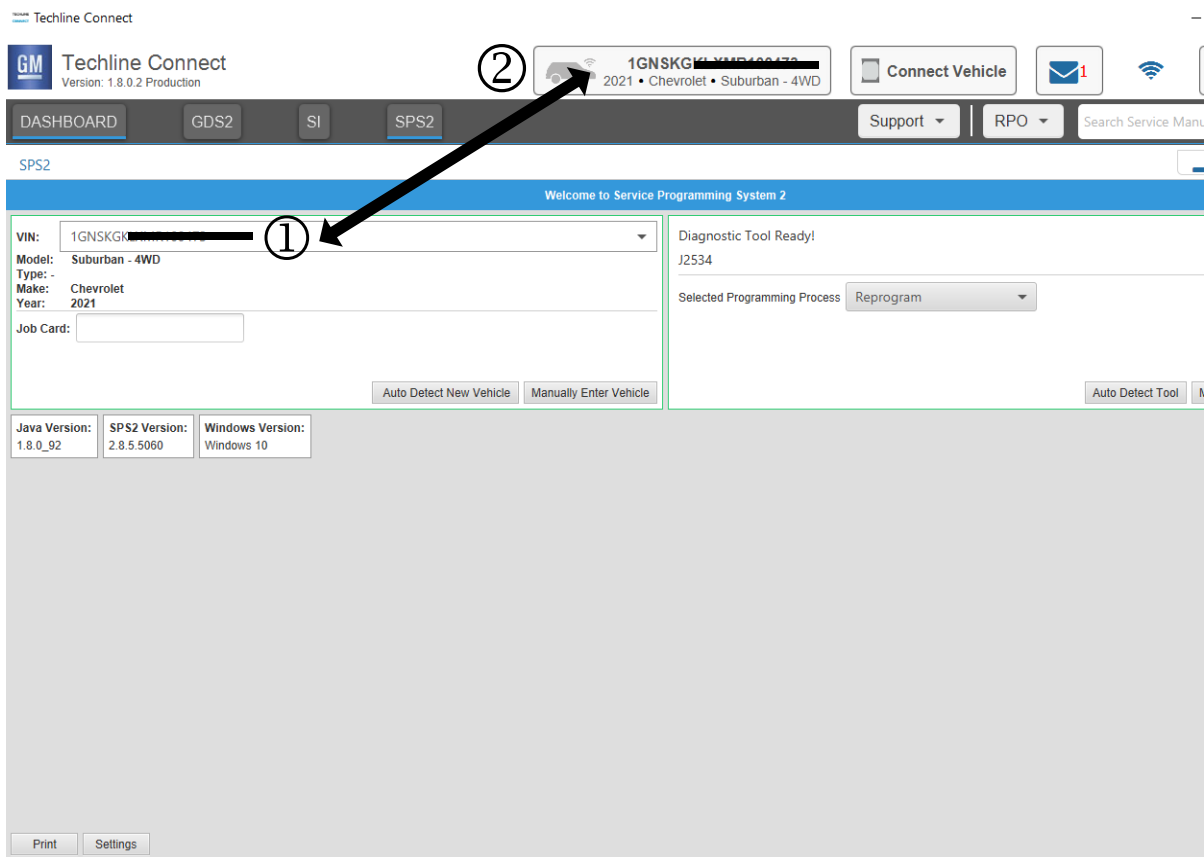
5644477

Caution: Be sure the VIN selected in the drop down menu (1) is the same as the vehicle connected (2) before beginning programming.

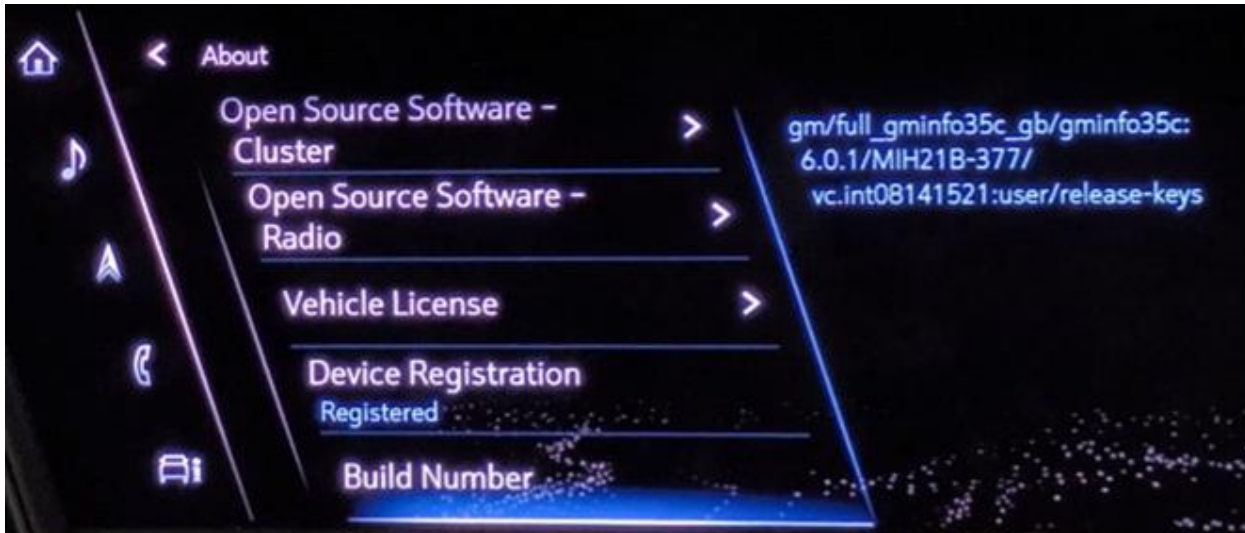
5766434

Important: It is important to ensure that the technician is inspecting the full information found within *Build Number*. To identify the current software installed in the radio requires the user to locate the *Build Number* to view the full software version file name. In the middle of this long file name look for 382. (The illustration below shows software version 377, thus that would be outdated.) The number would be numerically lower if the radio is not up to date, or numerically higher if newer versions were released and installed.

1. Inspect the current radio software version. Navigate to Settings -> About -> Build Number to view and verify the software version.
 - If equal or greater than 382, this bulletin does not apply. Refer to SI for diagnostics.
 - If less than 382, update the radio software via USB. Refer to A11 Radio: Programming and Setup in SI.
2. Reprogram the Radio. Refer to *A11 Radio: Programming and Setup* in SI.

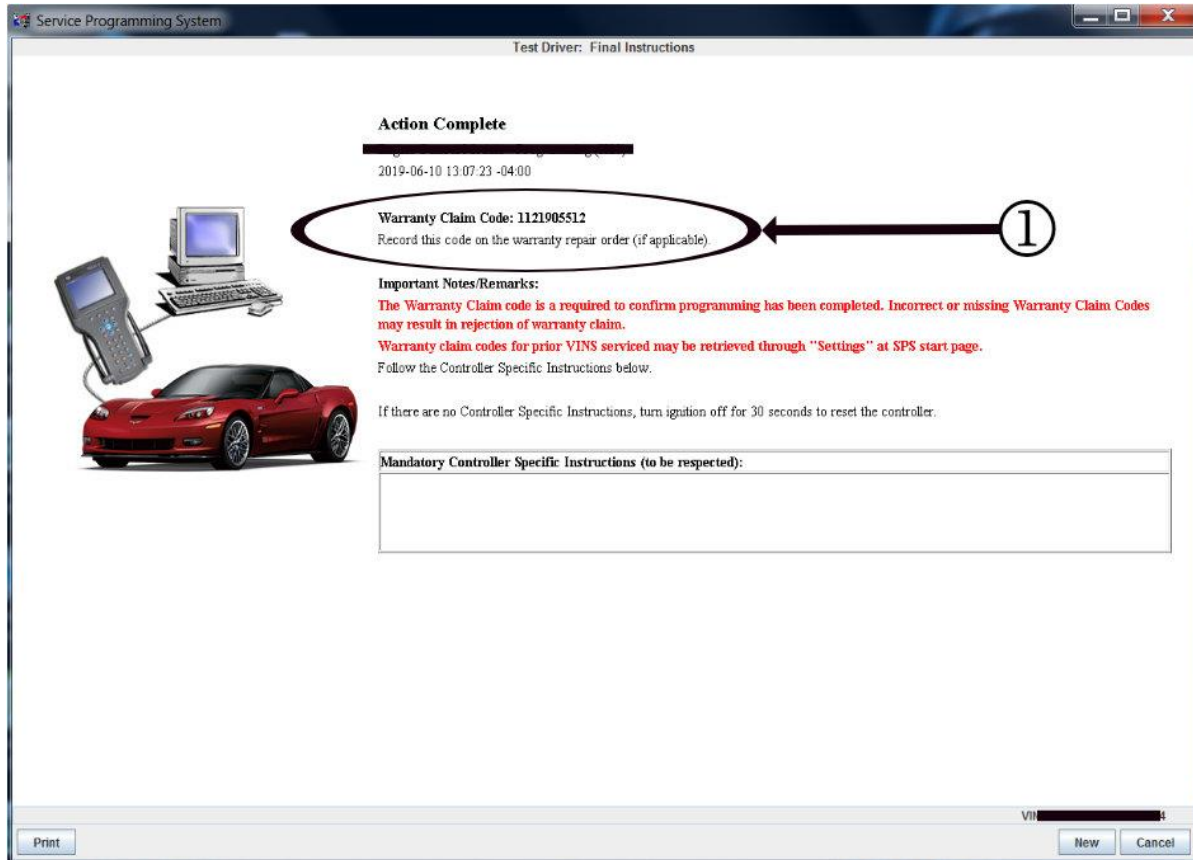
5431209

Important: To avoid warranty transaction rejections, you **MUST** record the warranty claim code provided on the Warranty Claim Code (WCC) screen shown above on the job card. Refer to callout 1 above for the location of the WCC on the screen.

3. Record SPS Warranty Claim Code on job card for warranty transaction submission.
