# AfterSales BOL Technical Information

## MAS002560 (BOL 21-08)

### Tunnel Phonebox anomalies

**Models:** M161 MY21

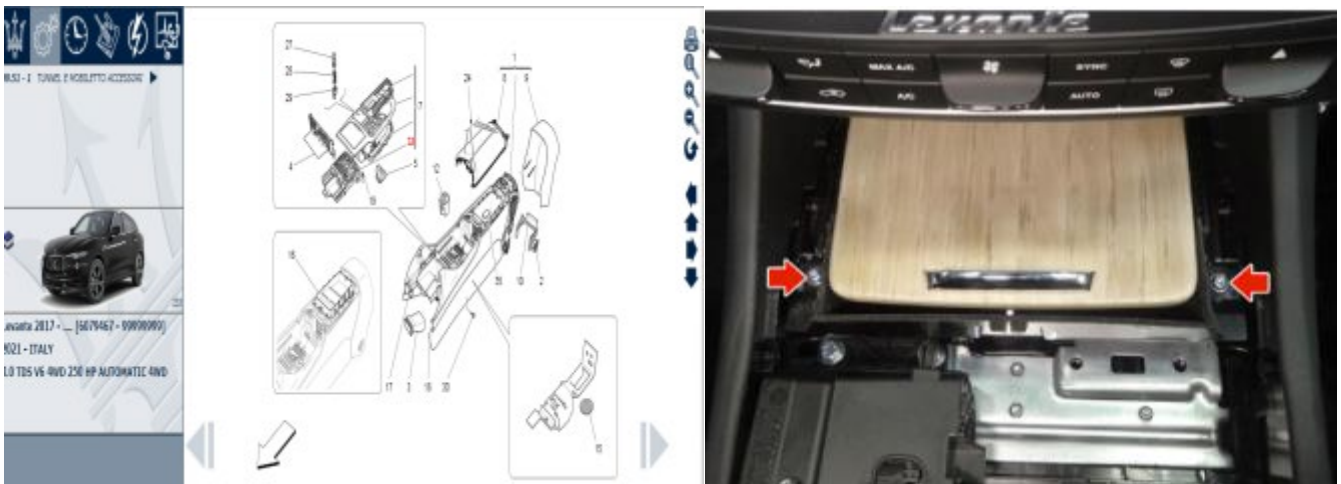
**Issue:** Difficulty opening or closing of the tunnel phone tray.

**Cause:** Incorrect handling of the tunnel phone tray when opening or closing.

Figure 1: tunnel phone tray (component n°32 in the section 09.51 – 1 ACCESSORY CONSOLE AND CENTRE CONSOLE of the spare parts catalogue)

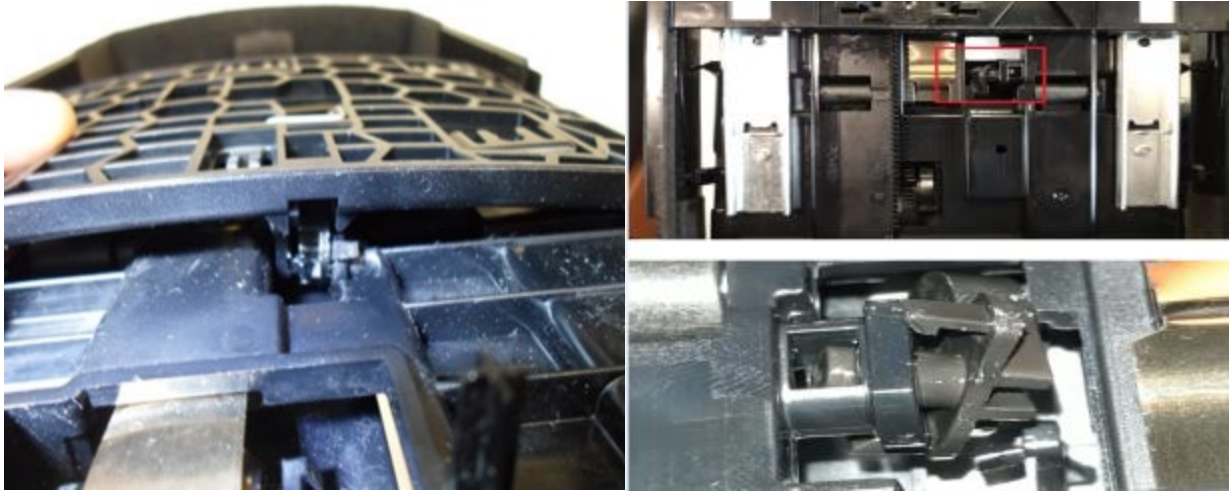
**Action:** An analysis carried out on the replaced parts showed that several breaks on the component are due to incorrect operation (forcing) the tunnel phone tray when opening or closing.

Figure 2: mechanism damaged/blocked by excessive force on it when operated.

Please inform Customers on how to correctly open/close the phone tray (as indicated in the Owner's Manual and the sticker applied in production, Fig.7 ) and to avoid possible interference caused by objects contained in the compartment which can damage the opening/closing mechanism.

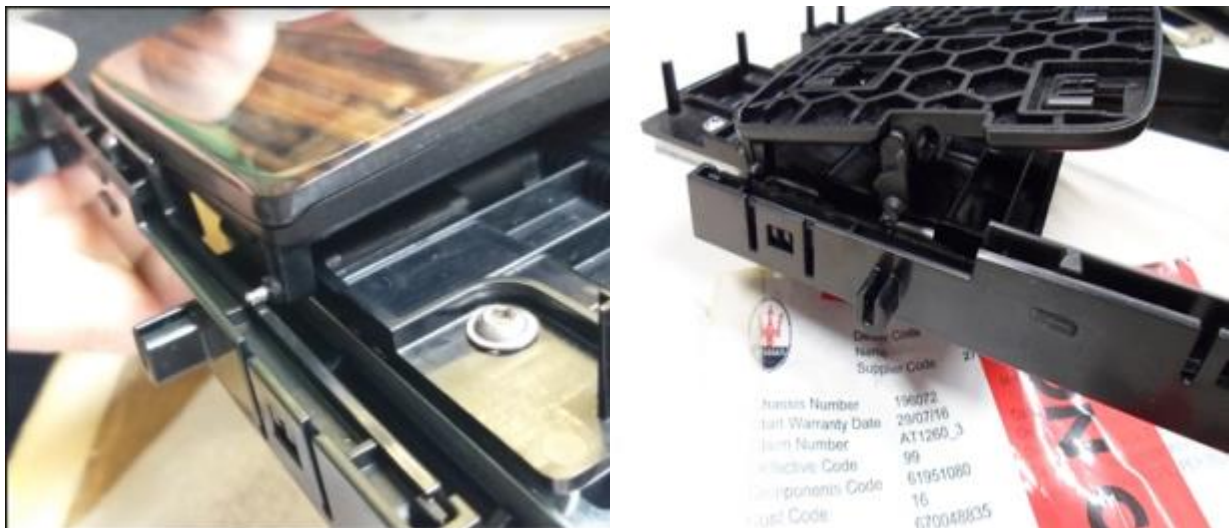
Figure 3: pins that came out of the guides caused force or interference with objects inside the compartment.

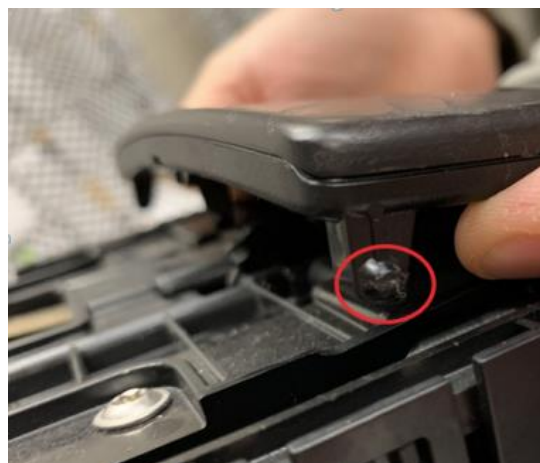
Figure 4: pin damaged due to excessive force or interference with objects inside the compartment

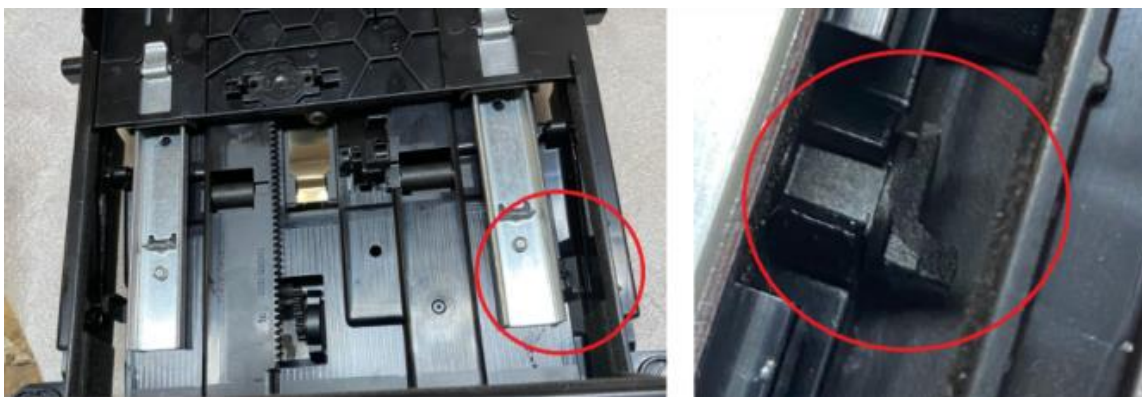
Figure 5: pins damaged due to excessive force or interference with objects inside the compartment.

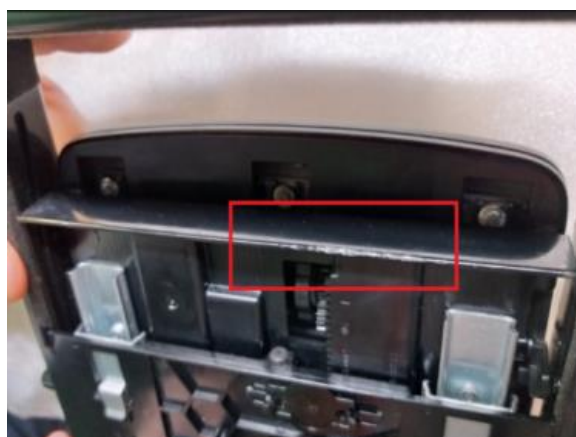
Figure 6: signs of interference with objects inside the compartment

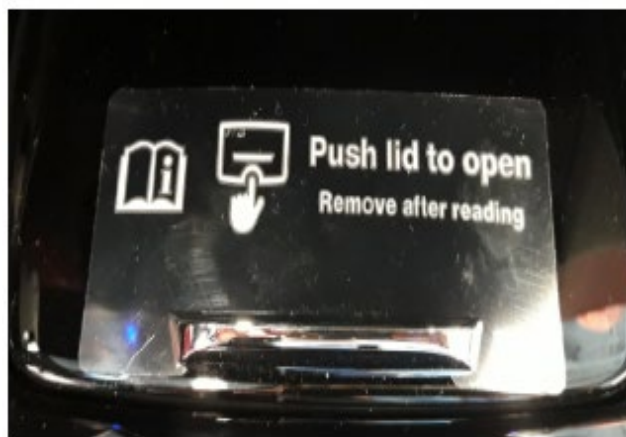
Figure 7: sticker applied at Production Plant.
